SUDAN & NUBIA

Volume 27

Preliminary report on the excavation of Building 1000 at Naga

Karla Kroeper and Christian Perzlmeier

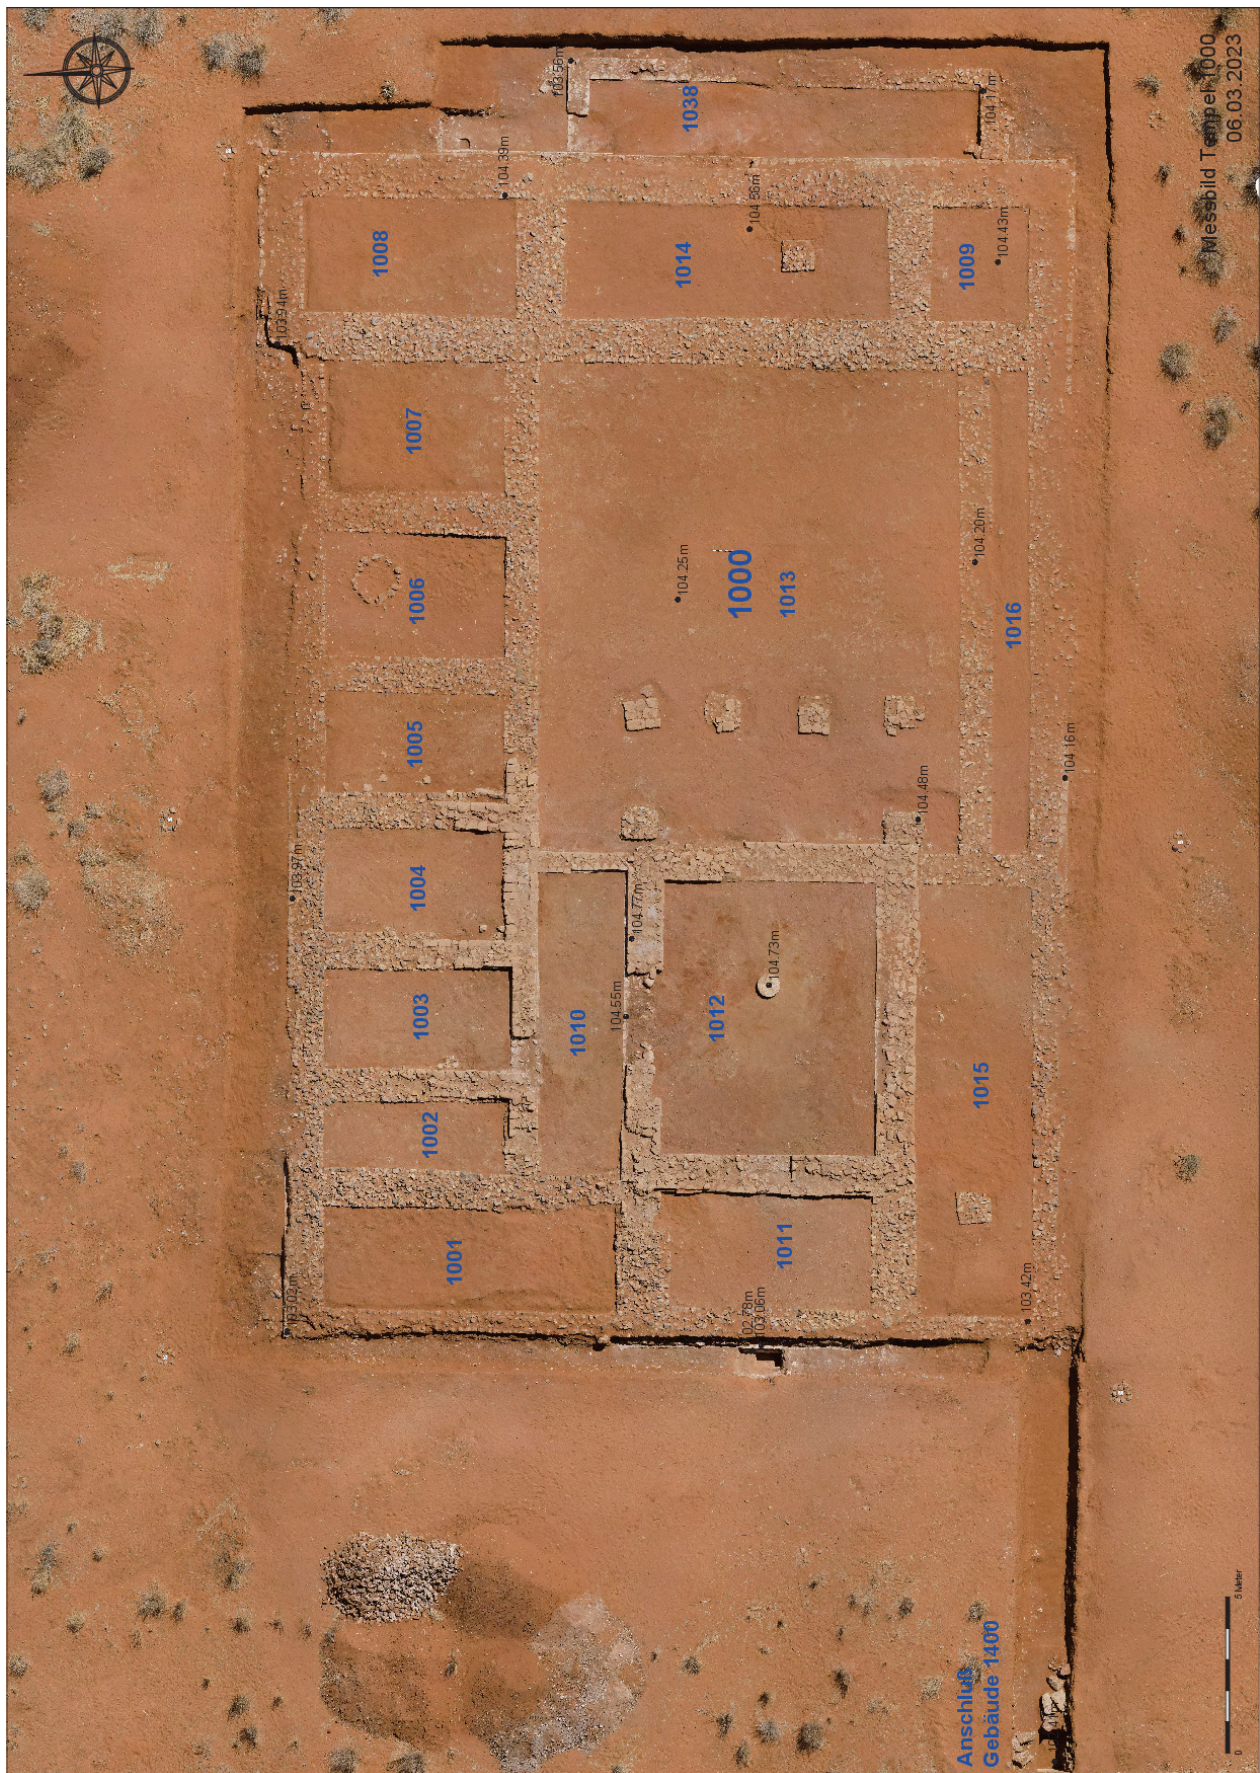
Figure 2. Plan of Building 1000 with room numbers and ramp at the east side (© Naga Project).

Only two doorways were preserved, one between Rooms 1012 and 1010, and another from 1010 to 1003 leading to the northern room compound comprising eight rooms. However, no door sills were found in any of the other rooms so that movement to and from these rooms could not be established. The probable approach to this central room (1012) was from the east through a now destroyed doorway from Room 1013. Here four free standing pillar foundations and two others close to the outer wall (north and south) were located. One should consider this area to have consisted of two parts: a covered porch fronting the entrance to 1012, this being approached through the large open courtyard (Room 1013). The most eastern adjoining 'rooms' 1008, 1014 and 1009 may not be rooms at all, but only the subdividing walls built into the podium to stabilise the approach to the building. Since only foundations are preserved, a final statement is difficult to make at this time. A similar situation was encountered in Building 3400 (Kroeper and Perzlmeier 2022, 152ff.) where several cross walls built into the podium were at first thought to represent rooms, but were later discovered to be internal walls in the podium to stabilise the fill.

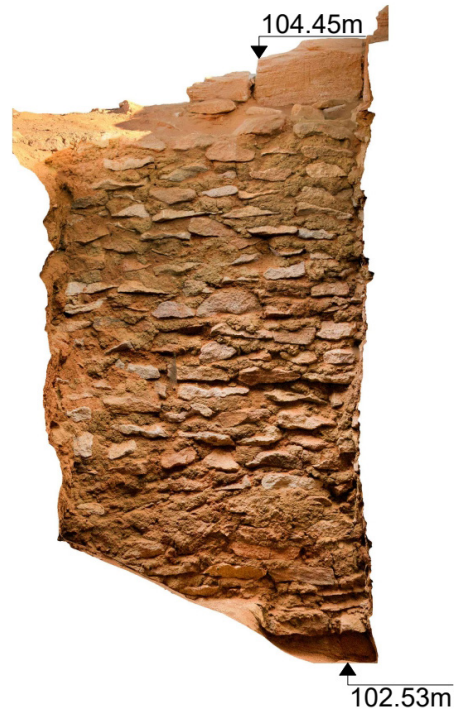
1011 Profil 01

Figure 3. Section in the northeast corner of 1011 showing the foundation consisting of gravel at the bottom, rubble sandstone plates with tough clay between the layers, followed by roughly worked sandstone blocks, on top of which the first layer of the actual wall was placed. View from south to north. (© Naga Project).

Generally, the temple walls were built on rather solid stone rubble foundations almost 2m deep (Figures 3 and 4). The east-west arrangement of 1000 is flanked on the south by two long rooms, with no. 1016 appearing more like a hallway than a room. The ramp 13.25m long (discovered in 2023), was built parallel to the eastern façade of the building running from north to south with a final height at the south end of 0.98m, which corresponds to the height of the podium (Figure 5).

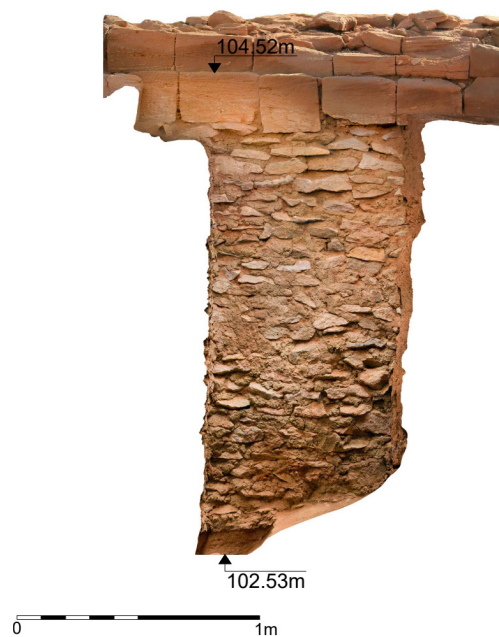
1011 Profil 02

Figure 4. Section in the northeast corner of 1011. View from west to east (© Naga Project).

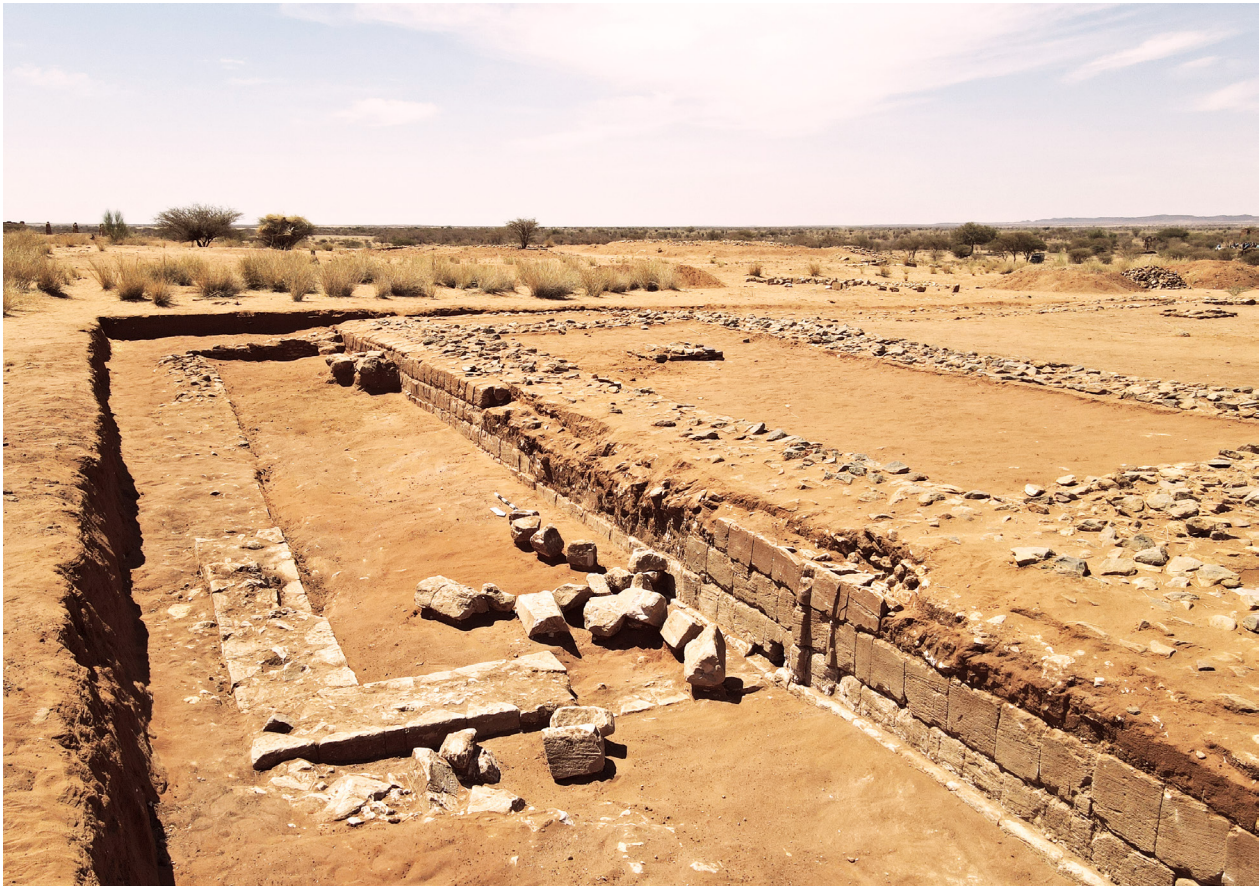
Figure 5. Ramp 1038, view from north to south, including the entrance and double wall section (© Naga Project).

Unfortunately, the doorway from the ramp into the building has not survived. The outer ramp wall was also built of stone with a double wall arrangement as mentioned above. The podium retaining wall is in part well-preserved. Remains of a panel decoration (Figure 6) visible on the wall near the entrance of the ramp, may have been similar to that known from the Podium Temple 1200 (Kroeper 2019, pls 7, 12).

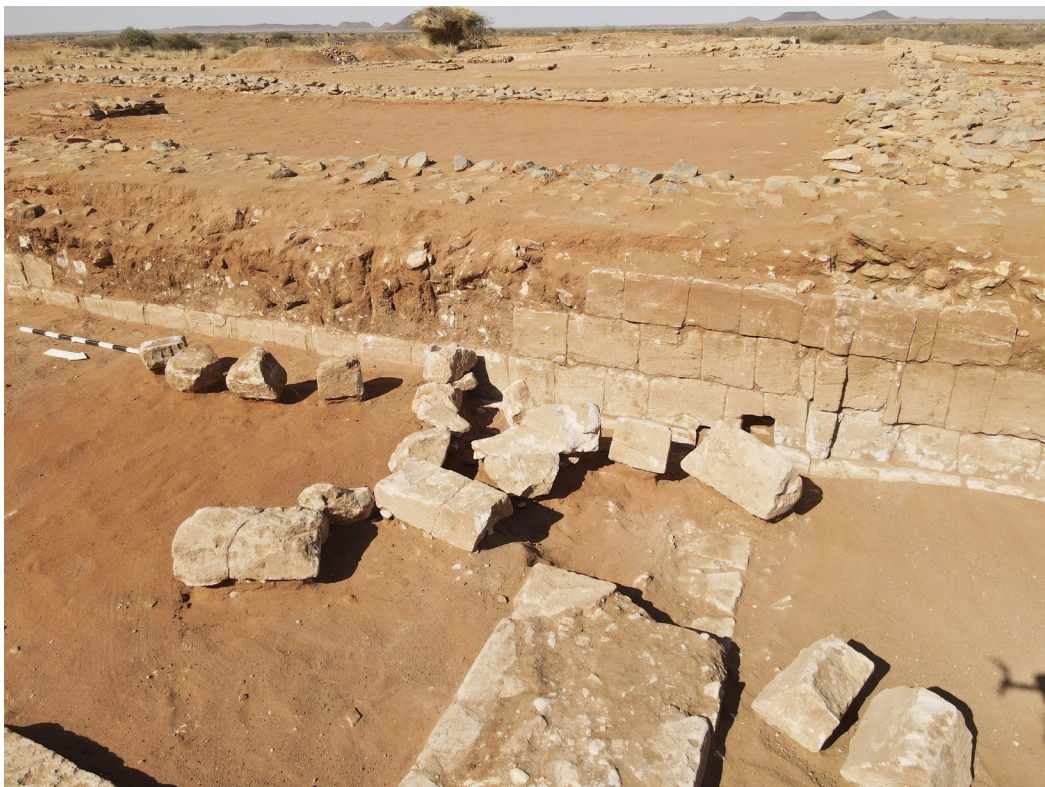
Figure 6. View from the east to the podium with some paneling visible. In front of the podium is the entrance to the ramp (on the left) with some balustrade blocks and other collapsed stones of the decorated entrance (© Naga Project).

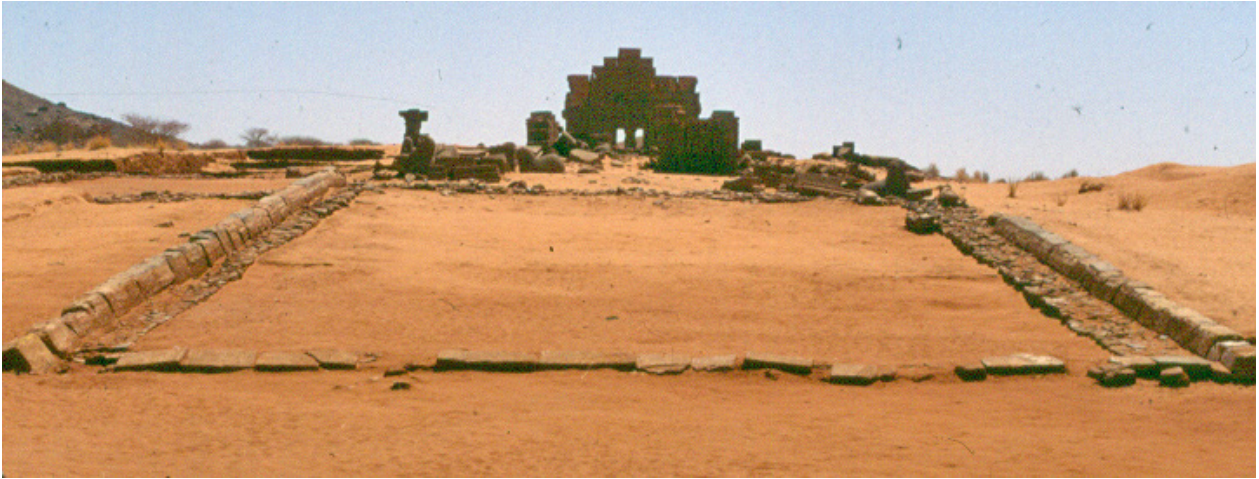
Figure 7. The entrance ramp of the Amun temple at Naga with the balustrade made up of large triangular blocks still *in situ* (© Naga Project).

Furthermore, some fragmentary decorative elements still preserved at the beginning of the ramp indicate that the entrance gate originally had highlighted details. Especially interesting are the long triangular stones, which were used as a balustrade, placed on the outside wall of the ramp. A similar construction is known from Temple 1200 and is also especially well-preserved at the entrance ramp of the Amun temple in Naga (Figure 7).

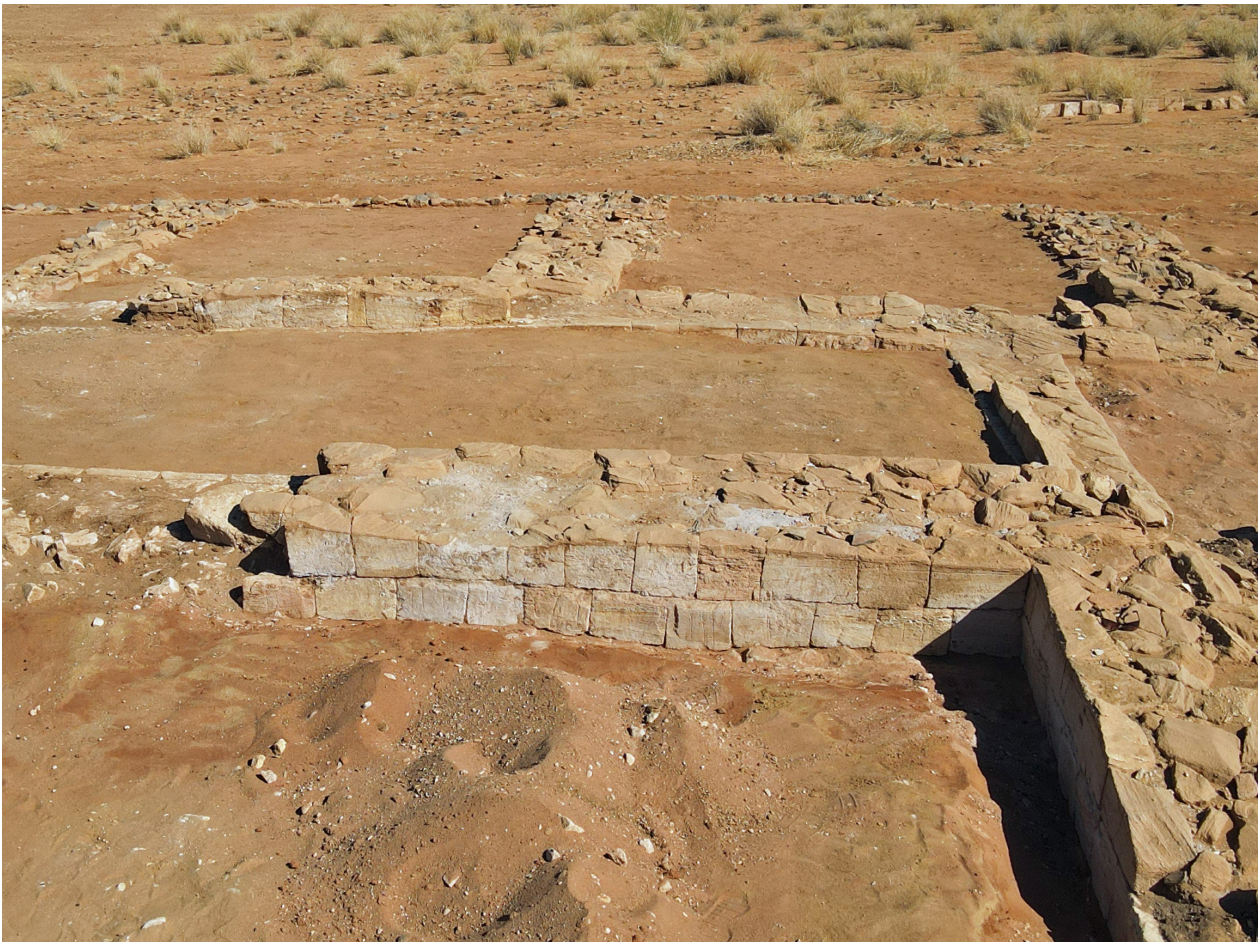
Figure 8. View of the inner north wall of Room 1012. At the bottom, roughly hewn stones, on top of which the last foundation stone with workmans signs engraved and the first block of the actual wall was placed, here all *in situ* (© Naga Project).

The best-preserved walls, consisting of the highest of the foundation blocks as well as the first row of wall blocks, were found in Room 1012 (Figure 8). At the beginning of excavation, the floor was covered with rubble, broken stones, and fragments of flat stones with plaster.

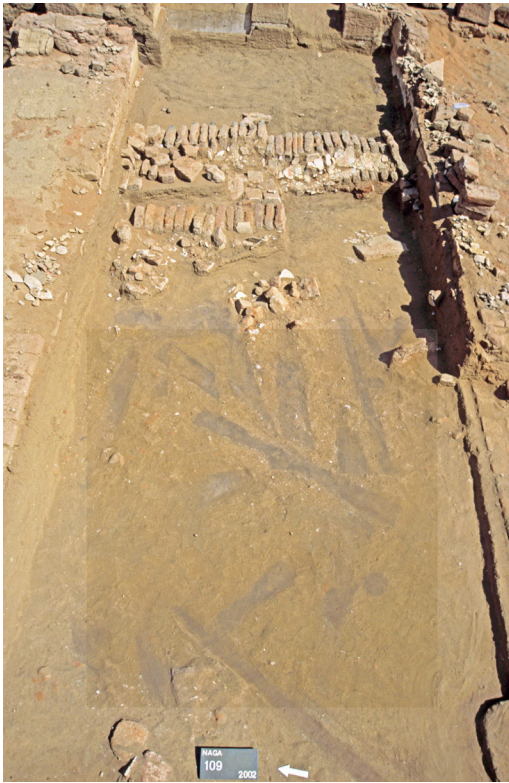
Figure 10. Floor of Room 109 in the Amun temple. In the foreground the remains of beams, which had carried the roof construction, are still visible (© Naga Project).

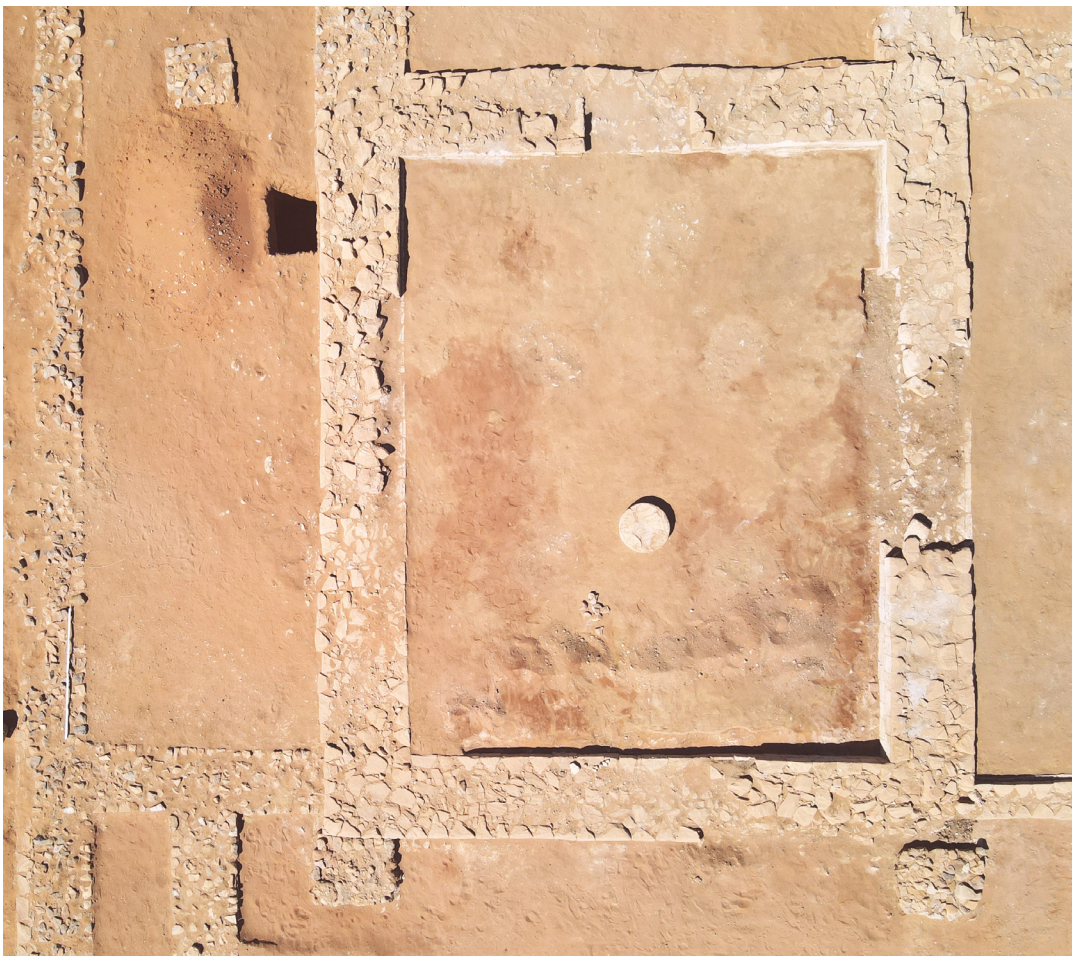
Figure 12. Floor of Room 1012 after removal of rubble. Very strong discolouration of the surface is evident throughout the floor level due to disintegrated painted wall decoration (© Naga Project).

and 12). Surprisingly, on this level many blocks, or fragments thereof, with relief decoration were found. After locating and removing the blocks it became clear that this room had been decorated with extensive painted reliefs, these having collapsed onto the floor, mostly face down, so that the pigments of the paintings had discoloured the floor. Although many of the blocks had lost their colour over time, some are preserved in an almost pristine state showing for the first time the actual colourful state of the reliefs, which in other buildings in Naga (i.e., the Amun temple) are not so well-preserved. The 87 relief blocks that survived in the sand and rubble when completely preserved, varied in size but not to a great extent averaging about 395x260mm, and almost all have, even if very miniscule, paint remains of mostly red and yellow colour. A small selection of the decorated blocks found will be presented here.

After the removal of rubble an amazing amount of red ochre discolouration, mixed with a smaller amount of yellow and blue-green pigments, was noted in the sand (see Figures 8

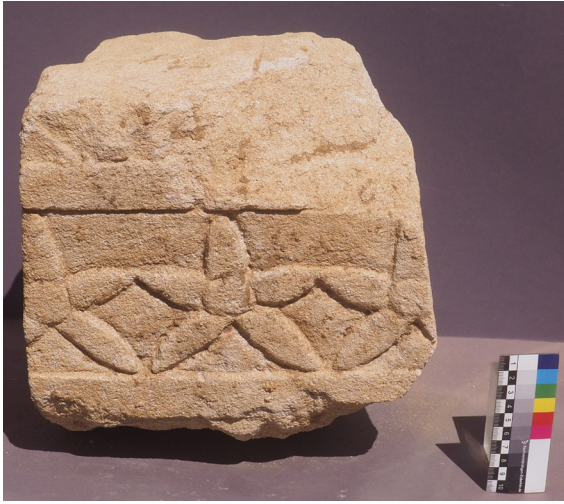
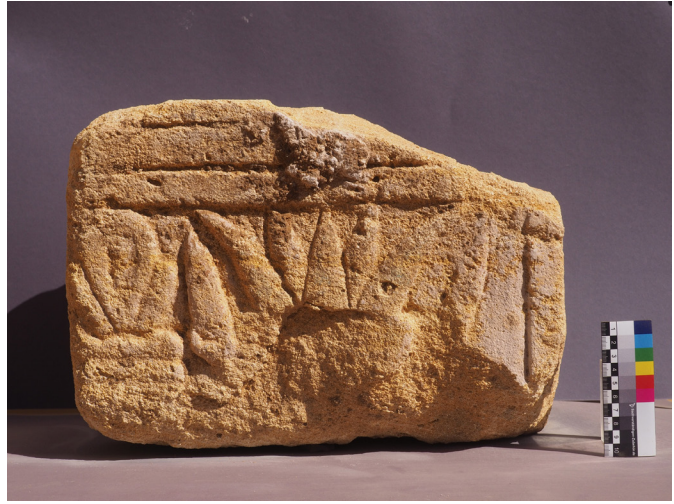
Figure 28. Blocks with star frieze from the upper part of the wall (© Naga Project).

Figure 29. Blocks with papyrus plants alternating with ankh-signs probably from the lower part of a doorway, as was found also in Temple 1200 at Naga (Kroeper 2019).

Architectural features belonging to the upper edge of the temple including cavetto, cornices, torus, and tooth mouldings as well as star frieze and doorway blocks were also preserved (Figures 28 and 29).

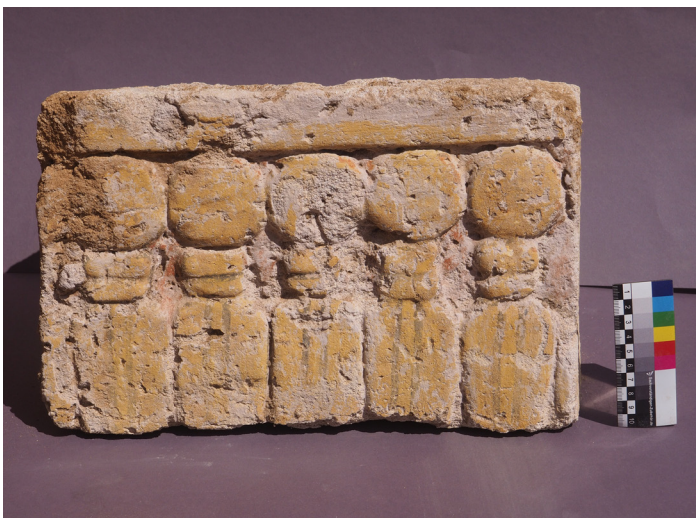
Figure 30. Uraeus frieze with thick layers of yellow ochre preserved (© Naga Project).

The best-preserved architectural feature consisted of eight large blocks with an uraeus decoration with very thickly applied yellow paint. Details of the snake markings were added in dark red paint (Figure 30). Unfortunately, no traces of inscriptions were found; these were possibly only applied with paint.
