The Meroitic settlement at Damboya: preliminary results

Gabrielle Choimet

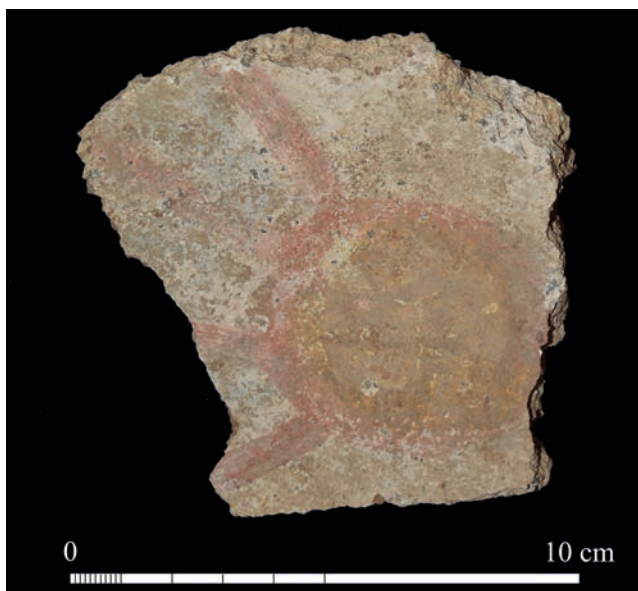
Figure 1. Sector C, fragment of painted plaster showing a trefoil motif (© SFDAS/musée du Louvre).

Although Sector C did not yield any structure, very large quantities of plaster were found in the demolition layer, amounting to nearly 3000 fragments. Of these, c. 350 fragments bore traces of paint, mostly yellow but also red, as well as some traces of blue and – more rarely – black. Examination of these pieces of painted plaster showed that the motifs used were extremely repetitive and probably consisted of floral designs (trefoils¹) arranged in a frieze (Figure 1), a type of decoration also found on ceramics (Figure 2). Finally, yellow

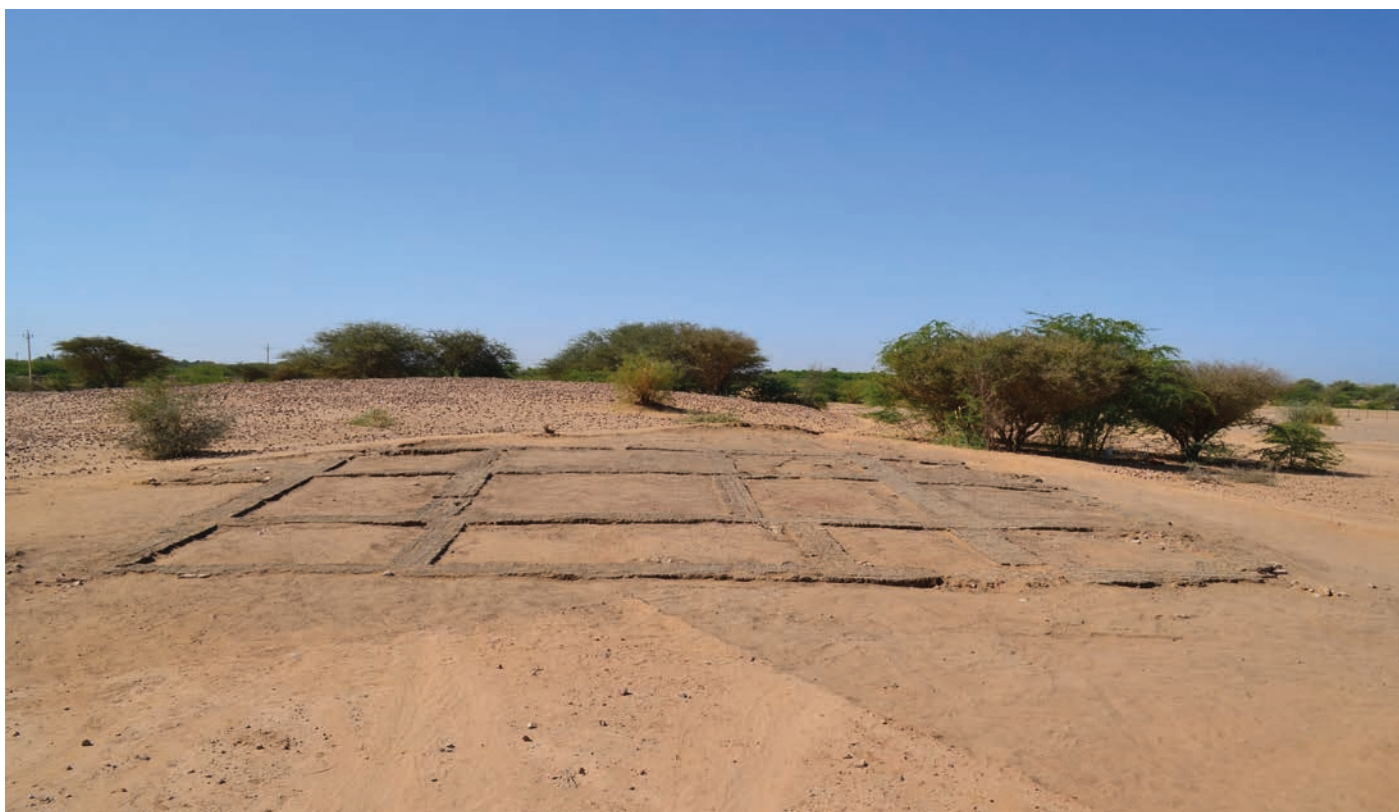
Figure 3. View of Building E after excavation from the northeast (© SFDAS/musée du Louvre).

afterwards, suggesting the presence of a structure beneath. Surface cleaning exposed a rectangular mudbrick building, immediately below the present ground surface. An area of 800m² – i.e. eight 10x10m squares – was cleared with the intention of obtaining the complete plan of the edifice to gain a preliminary understanding of its organisation (Figure 3).

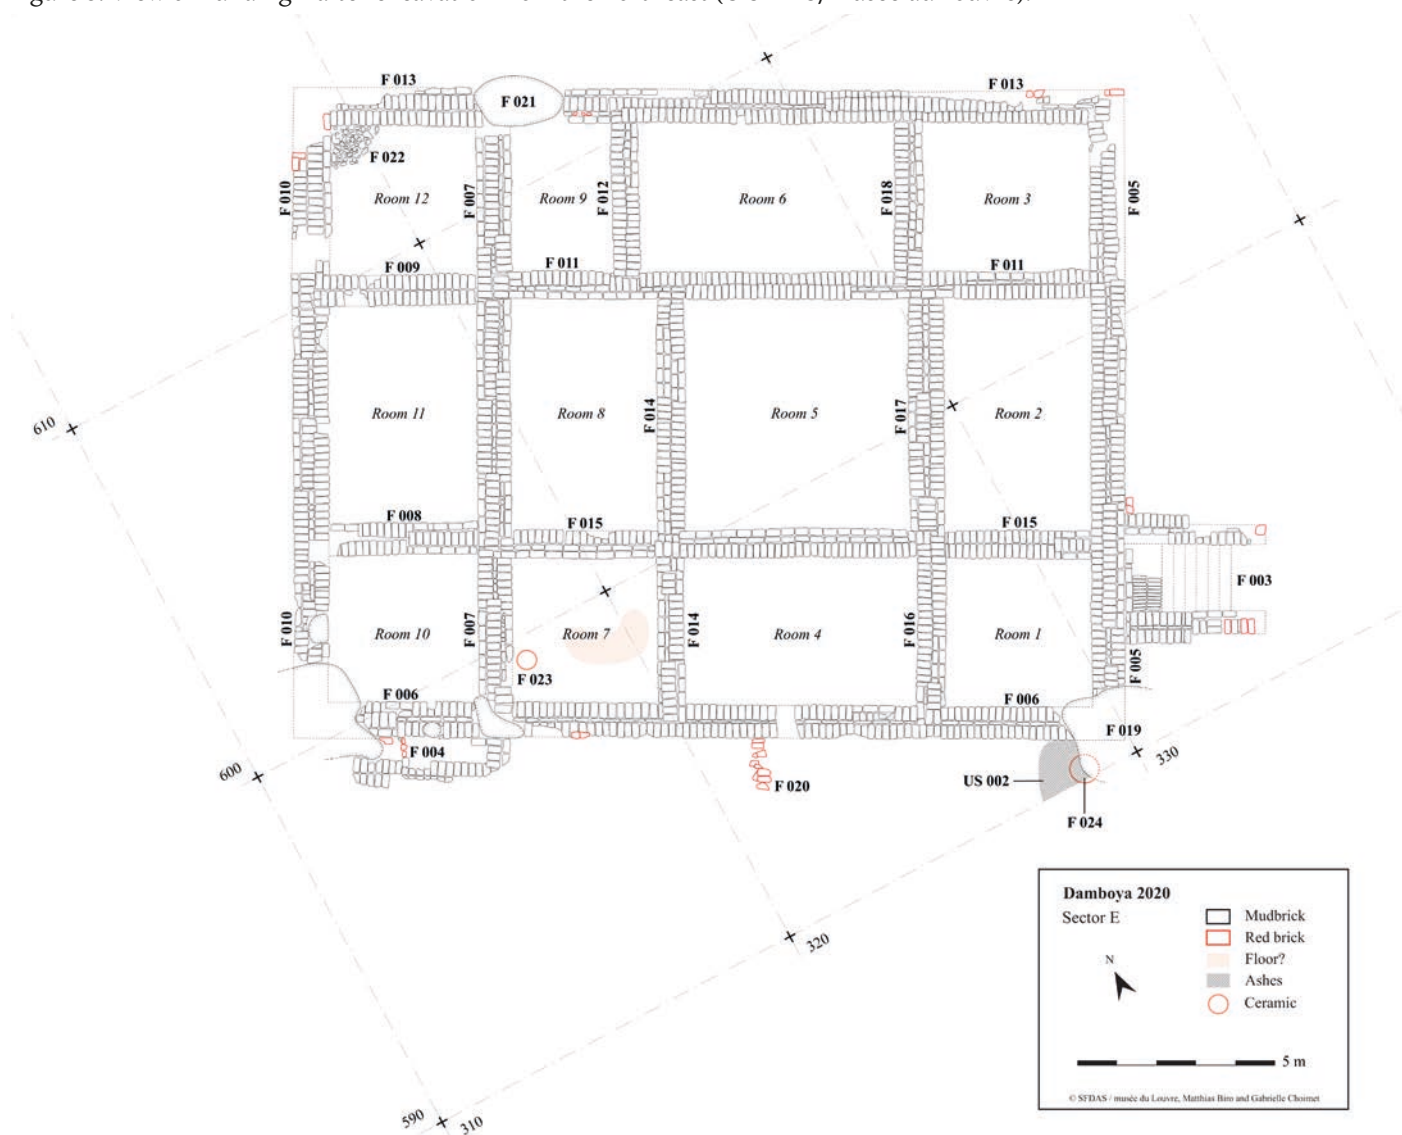
Figure 4. Plan of Building E (© SFDAS/musée du Louvre).

Building E measures 21.10m long x 16.20m wide, with its long axis roughly northwest-southeast (Figure 4). It shares the same orientation with the red brick temple in Sector A and also seems aligned with the construction beneath the main kom, as shown by the magnetometry performed in 2008. Due to intense brick removal – probably occurring up until recent times² – the edifice only survived to its foundation level, of which two to three courses have been unearthed so far. The structure was disturbed by several pits dug in order to reuse the building material, either to face wells, to erect new buildings or to fertilise the fields in the case of mudbrick. Exterior walls were systematically plundered at the corners, where the foundations have almost completely disappeared. These successive dismantling operations and the significant rain and wind erosion in the Butana region explain this poor level of preservation.

The structure's layout consists of a group of three x four rooms; the ones at the corners being more or less of square shape: Rooms 1, 10 and 12 (3.70m per side), except Room 3, which measured 4.10x3.70m. Its exterior walls F005, F006, F010 and F013 are approximately 0.90m wide (two brick headers and a half), while the inner walls are substantially thinner with a width of about 0.70m (two brick headers). Given the thickness of the foundation walls – and given that they are usually wider than the elevations – it is reasonable to assume that Building E had no more than one storey, in addition to the ground floor. Both were probably partly built of red brick to withstand the particularly rainy weather conditions in the Butana.

Building E is clearly structured initially around a tripartite edifice with a square plan framed by exterior Walls F005, F006 and F013 and inner Wall F007, a type of organisation which is found in the Butana as well as in Nubia (Maillot 2016, 198; Wolf 2019, 752). Here, the edifice is divided into three northwest-southeast spans, separated by Walls F011 and F015, the central span being wider than the other two (5.80m wide instead of 3.70m). The southern and central spans were then divided by Walls F014 and F016, while the northern span was partitioned by Walls F012 and F018, the latter two walls being deliberately shifted a few tens of centimetres to the northwest. The last row of rooms (Rooms 10, 11, 12) was later added against Wall F007, to the northwest of this first structure, the same width as the spans framing the central space. This original pattern is particularly visible in the bricklaying and in the thickness of the walls: Wall F007 crosses the entire width of the structure, it is as wide as the exterior walls and fitted in the same way, with alternating courses of headers framing bricks on edge and courses of stretchers framing headers and bricks on edge. In addition to this, Walls F008 and F009 abut Wall F007, while all the other walls are bonded together and are therefore contemporary. Finally, F008 and F009 are slightly offset in relation to Walls F011 and F015, of which they form the continuity. However, the similarity of the bricklaying and the building materials indicates that all these walls belong almost certainly to the same construction phase. Lastly, from what is observed at the foundation level, no trace of rebuilding activities has been found and no later alteration such as extension or reduction of the rooms has been discerned inside the building.

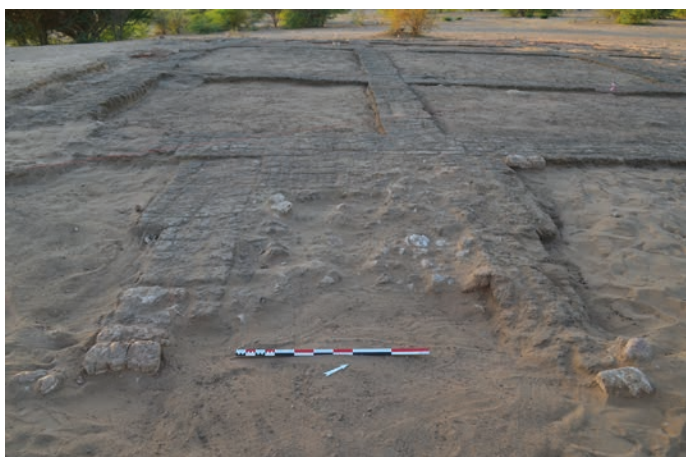
Figure 5. Staircase F003 (© SFDAS / musée du Louvre).

building lying underneath the main kom. Near the southern corner, Staircase F003 leans against Wall F005 (Figure 5). It is flanked on either side by two indented low walls framing a central staircase of which no steps have been preserved. The foundations of this entrance are made of mudbrick with some fired bricks found at the base of the two low walls. Two rows of bricks on edge abutting Wall F005 are quite certainly indicative of a threshold, c. 0.70m wide, either made of fired bricks, as in the ceremonial palace of el-Hassa, or of stone slabs. According to the remaining features, we can reconstruct a staircase of five or six steps – each 250mm wide and 120-150mm high. The floor surface inside the building must therefore have been about 0.70m above the exterior occupation surface, the edifice being built on a small podium.

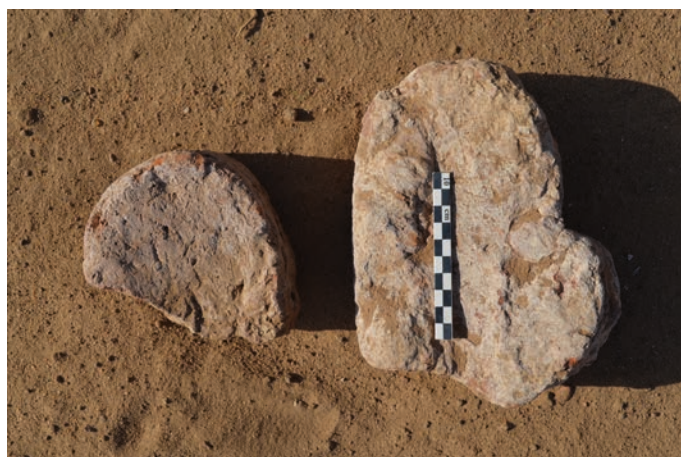
Figure 6. Two torus-shaped bricks from Square 310-590 (© SFDAS/musée du Louvre).

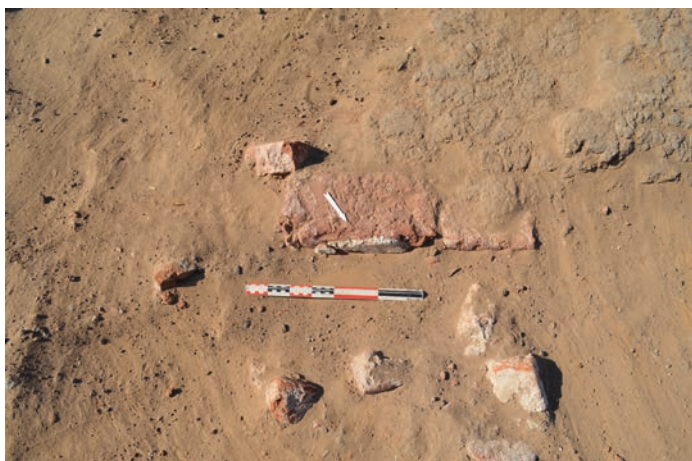
Figure 7. Facing plaster at the eastern angle of Building E (© SFDAS / musée du Louvre).

Elevations were plastered with white lime mortar as numerous fragments of plaster were found, including *in situ* on the outer face of a red brick at the eastern corner of Building E (Figure 7). A distinction can be made between exterior coatings and those applied inside the building. Thick white facing mortar with large grey mineral inclusions used as a temper was probably employed on the exterior façades, as it was found mainly outside the structure. Some of these plasters were covered with yellow paint. However, the interior of the building – especially the central Rooms 2, 5 and 8 – yielded a significant number of plaster pieces with finer sand inclusions. Most of these fragments were covered with paint, or even painted patterns. As for Sector C, the colours represented are first of all yellow, then red (also used to outline the motifs which unfortunately could not be reconstructed), a very well preserved Egyptian blue and rare occurrences of black lines. Square 320-590 delivered some fragments of a third, harder type of mortar, whose temper consists of fine red sand. Finally, a few pieces of plastered and painted sandstone have been discovered, including a column drum with traces of painted coating in the debris of Room 2.

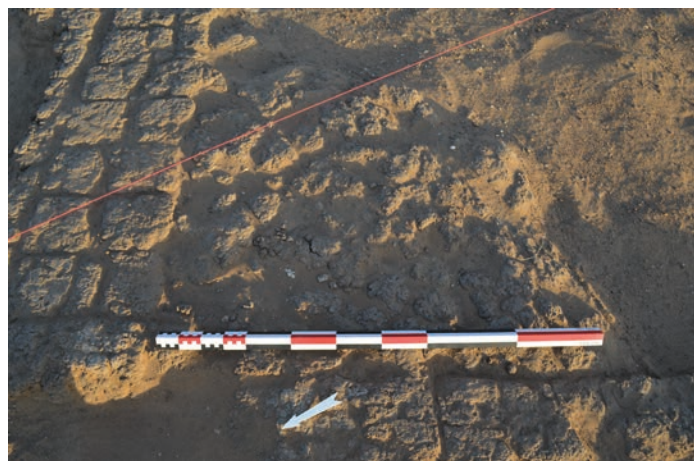
Figure 8. Mudbrick structure in Room 12 (© SFDAS/musée du Louvre).

Lastly, a small unusual quarter circular feature (F022) paved with mudbrick debris was set in the northern corner of Room 12, along Walls F010 and F013 (Figure 8). The broken bricks are clearly the same as those used in the construction of Building E. Its function and dating are rather unclear but it may have been used to support an installation dedicated to heating, as burnt bricks and lime ('*kankar*') were found in its vicinity.

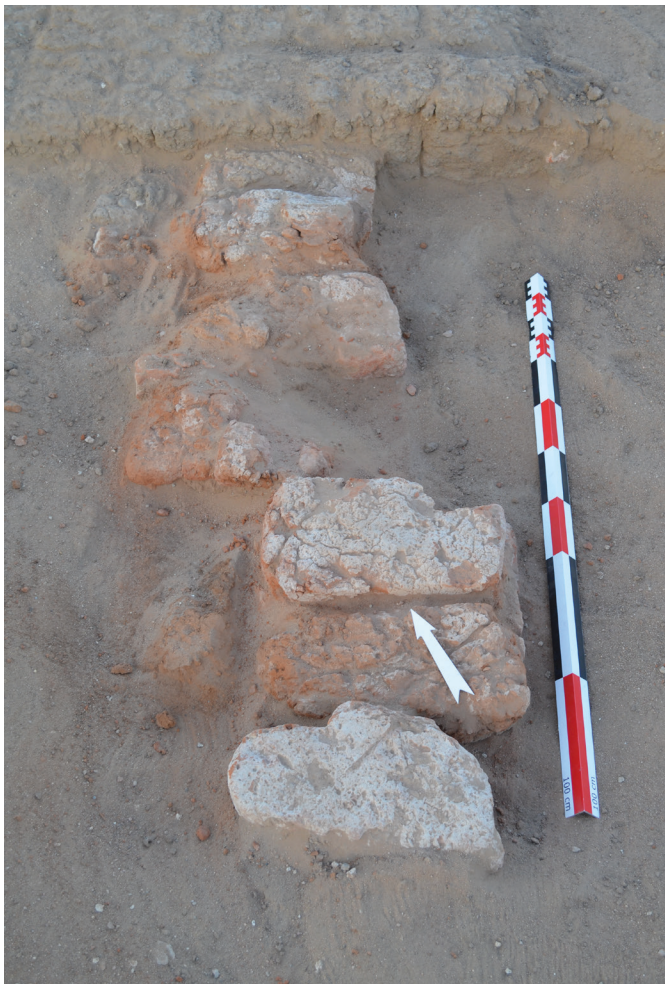
Figure 9. Redbrick wall F020 with torus moulding in the foreground (© SFDAS / musée du Louvre).

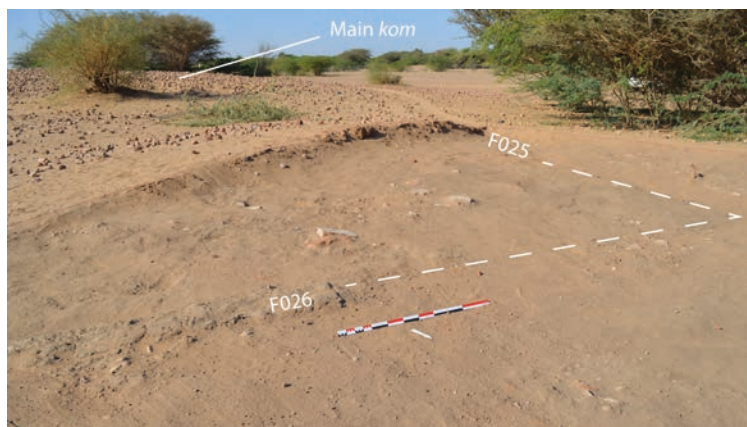
Figure 10. Negative of a mudbrick building in the southwest corner of Square 310-590 (© SFDAS / musée du Louvre).

The 2021 season will aim at excavating the different rooms of the edifice in search of occupation levels predating the construction of the building, as the site seems to have been previously populated as indicated by the ashy levels found in Sectors C and E. Surface cleanings will also continue southward since a second structure, similarly oriented but with thinner walls, was uncovered but not further investigated, at the end of the campaign (Figure 10).
