# Renders of the Amun Temple Complex in el-Hassa: practices, pigments and painting methods

Serge Feneuille

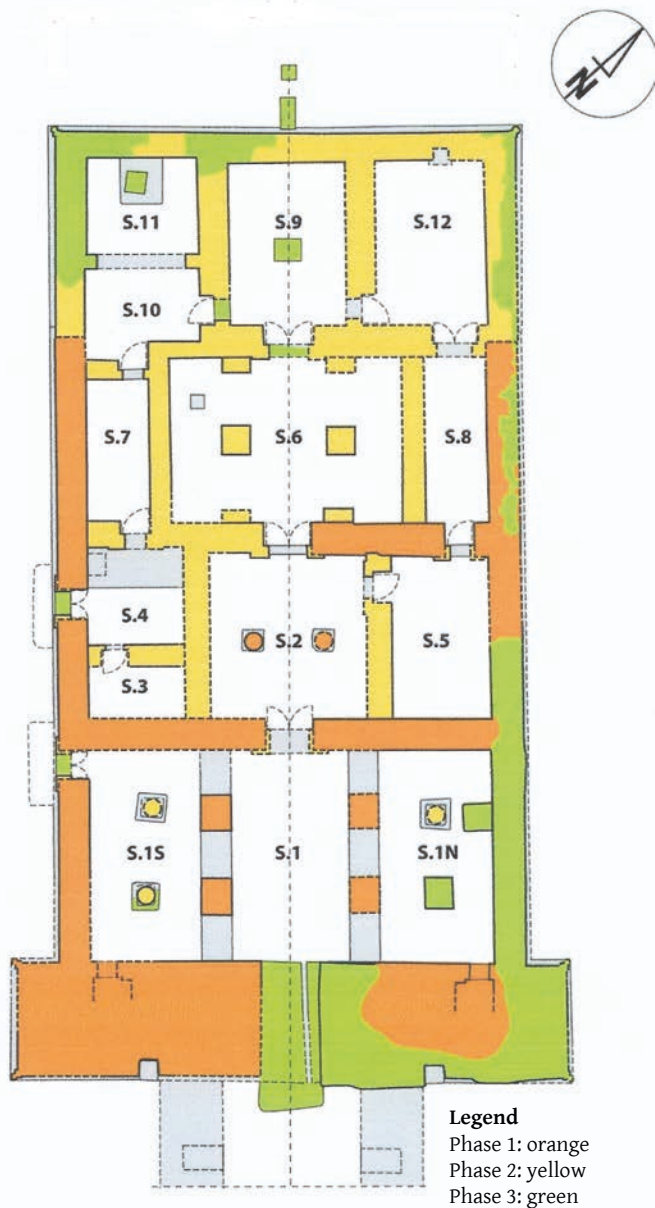
Figure 1. Vestiges of the temple in its different phases.

<sup>9</sup>Room S.9 on Figure 1.

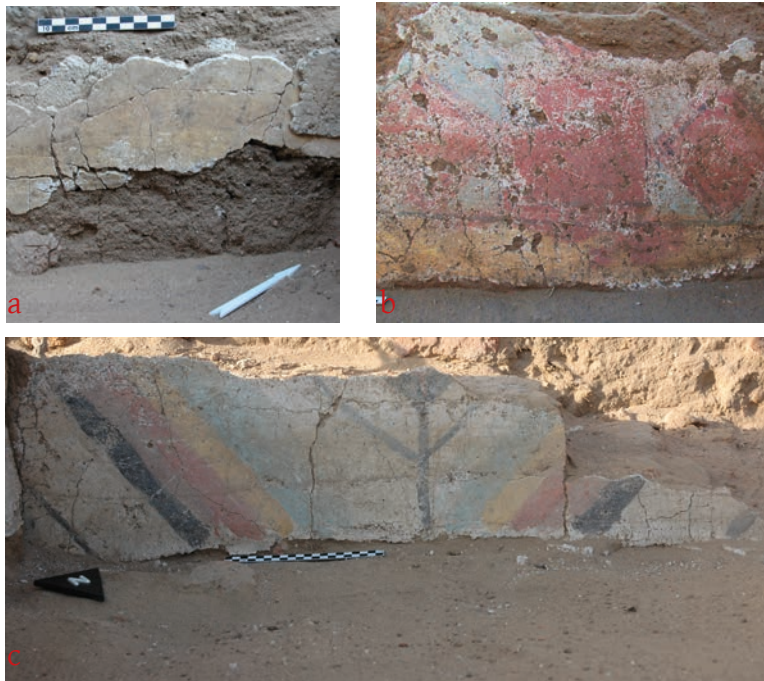
Figure 2. Traces of mortar *in situ* at the base of the walls of the temple and one of the rooms in the ceremonial palace.

- Wall renders on a few courses of terracotta bricks still visible at the foot of some of the walls (Figure 2) and on the bases of the rams along the pavements of the *dromos*; some of these renders have up to three layers, 10-20mm in thickness, and are painted in different colours (Figure 2a); a number are decorated with what could perhaps be taken for imitation marble reminiscent of Macedonian or Pompeian murals (Barbet 2009, Lazaridis 1997) (Figure 2b);

Only four pigments were used on all the painted fragments submitted for analysis: yellow ochre, red ochre, blue and carbon black, in extremely variable proportions. Yellow ochre was by far the most common and black was only found on a very small number of geometric designs (Figures 2c, 6a and 6b) or mixed with red ochre in the case of two renders found on walls still in place at the foot of the tower (Figure 2b). White was found on a very small number of fragments and is probably lime wash, at times applied on a pre-existing painted surface. A few fragments, mainly from the cornices of the courtyard behind the pylon<sup>5</sup> were, for example, clearly originally decorated with blue palmettes

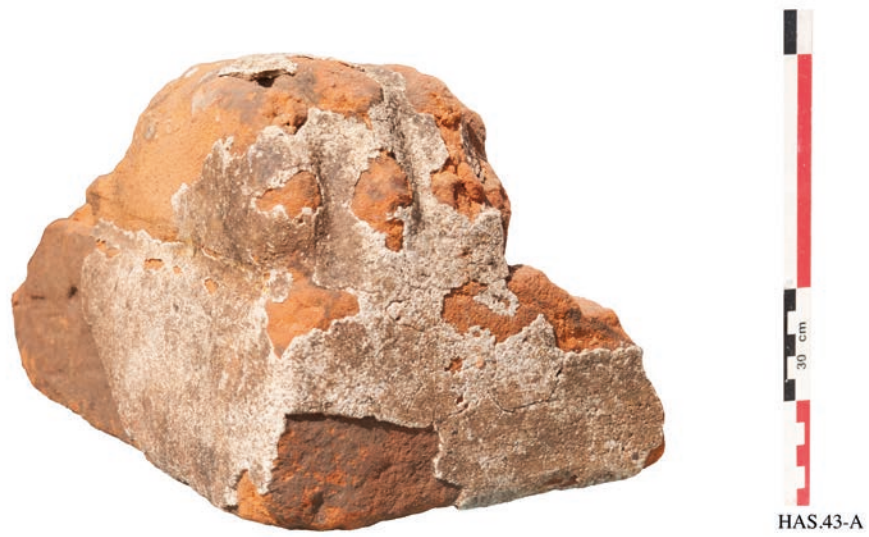
Figure 3. Traces of white mortar on a sandstone lion's paw.

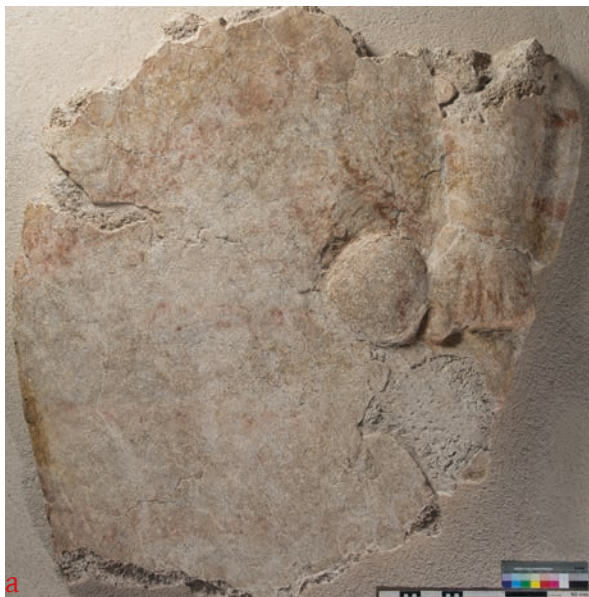
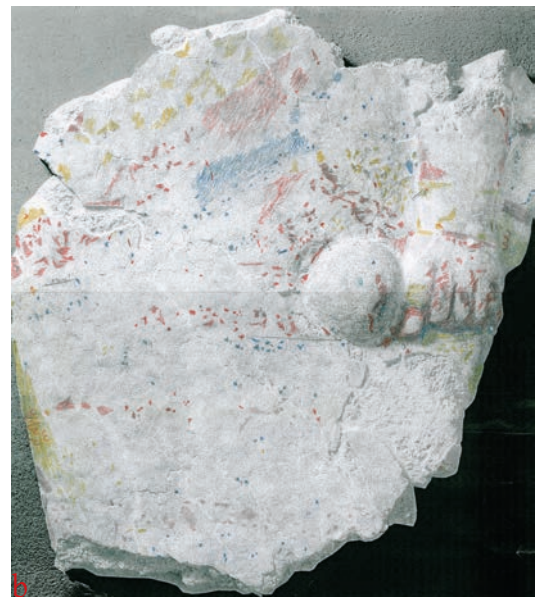
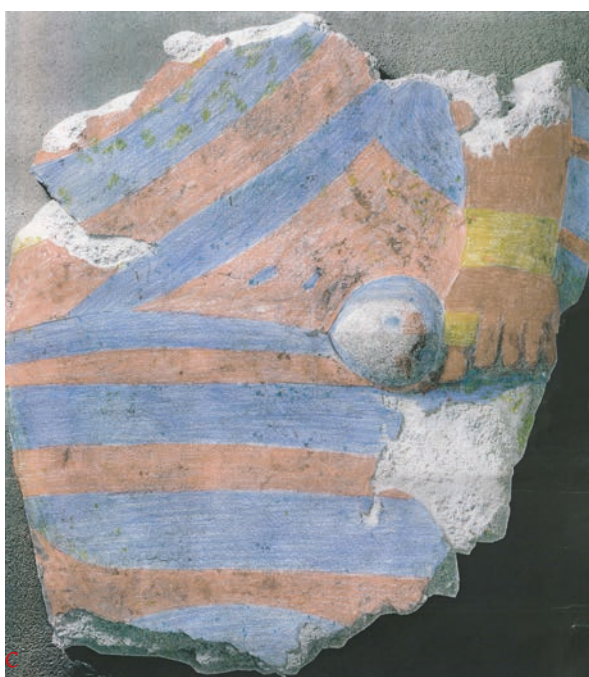
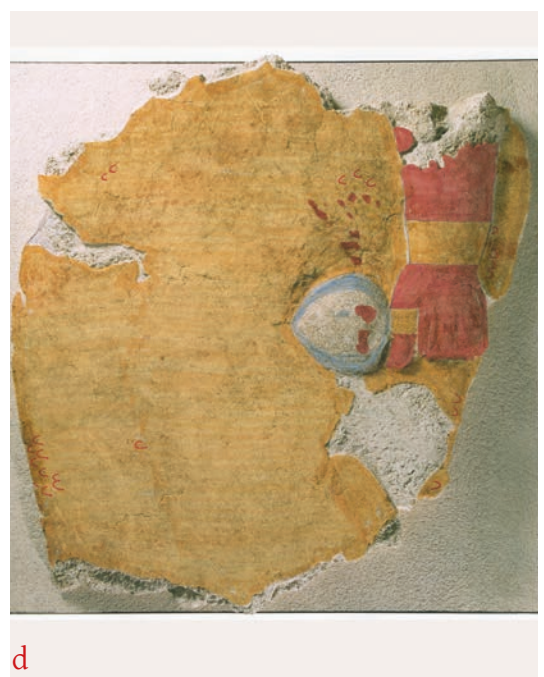
Figure 4. Bas-relief of mortar representing the pelvis of a Candace; a) after restoration; b) traces of paint; c) restoration of the decoration in Phase 1; d) restoration of the decoration in Phase 1.

- The dress worn by the Candace which, after conservation-restoration,<sup>10</sup> was discovered to have first been painted in red ochre and blue, and then overpainted with yellow ochre with touches of red ochre (Figures 4c and d);
- A royal head (Figure 5a) with its red ochre colouring and its yellow ochre chinstrap;
- One fragment where it was possible to identify part of a human torso wearing armour made of scales painted red on a yellow base (Figure 5b).

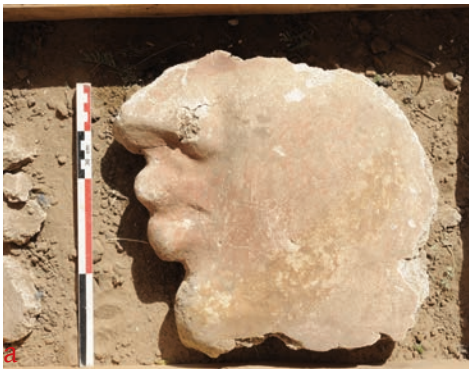
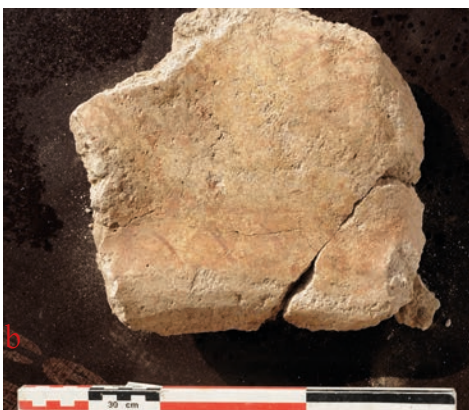
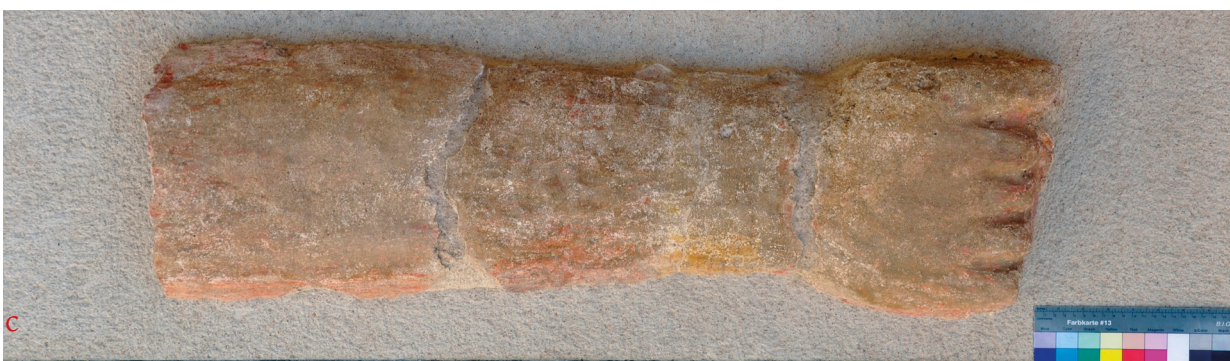
Figure 5. Fragments of mortar shaped to represent parts of the human body.  
a. Lower part of the face of a royal figure. b. Part of a torso. c. Arm reconstituted from four fragments.

to be ochre or blue in colour, with thicknesses ranging from a few centimetres to some 150mm for those where the colour had not worn away, and were of varying sizes, the biggest being in the region of 300mm for 45 such fragments (Figure 5). It was impossible to piece together these fragments, their edges not being cleanly broken, except for a forearm reconstituted from a hand and three other fragments<sup>4</sup> (Figure 5c). Here again, by measuring the parts of the figures still remaining, particularly the bottom of one face (Figure 5a) sporting a chinstrap (and therefore probably royal), their height could be estimated to be much the same as that of the Candace;

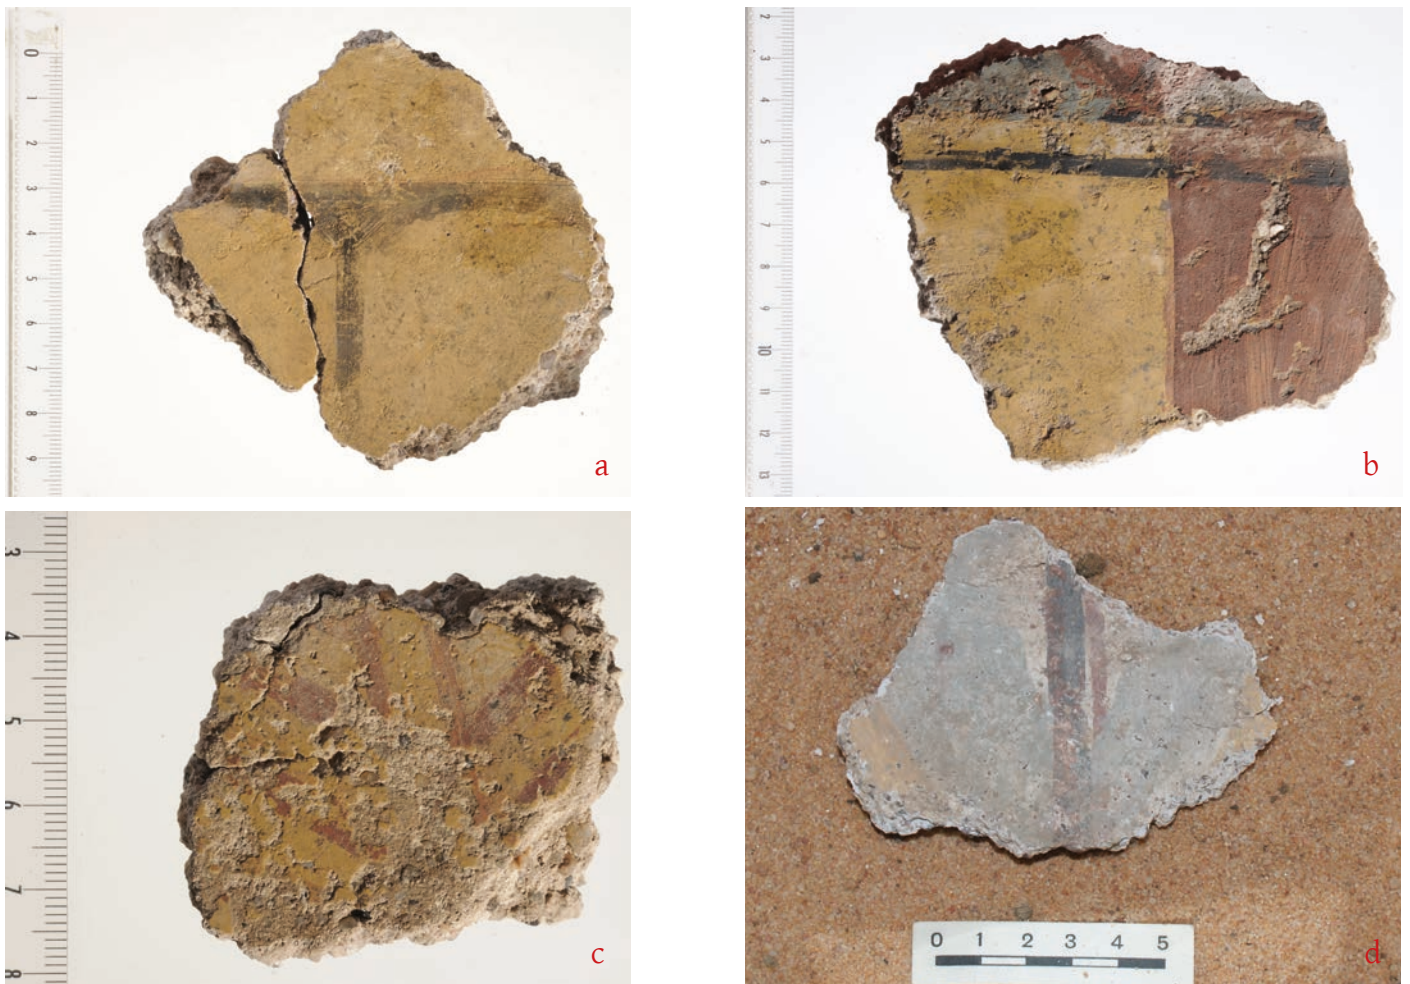
Figure 6. Decorated flat render fragments. a. Temple: north wall. b. Temple: Room 8. c. Temple: north wall. d. Ceremonial palace.

- A very large majority of flat render fragments from the walls, some still attached to their bricks, at times with two layers with different particle sizes under a flat surface that is either coloured or badly worn; the biggest of these are never more than 100mm in size and some even less than 20mm; once again, it was impossible to reconstruct these fragments (Figure 6);

<sup>6</sup>One of the fragments found in the ceremonial palace seems to be decorated with a figurative motif (flower stalk?) but this is so small that it cannot be confirmed with any degree of certainty (Figure 6d).

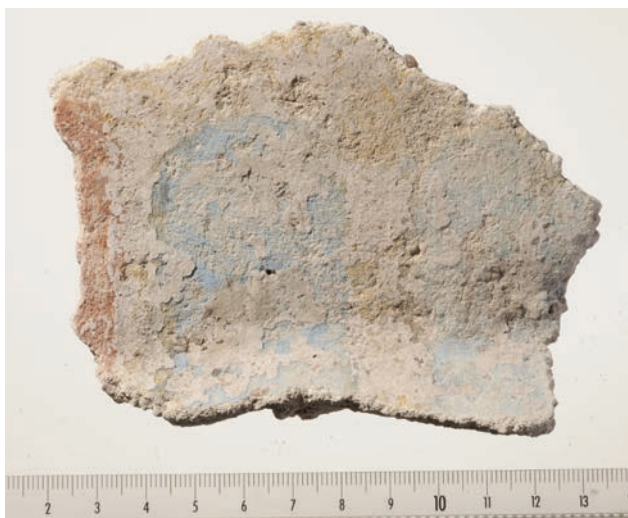
Figure 7. Fragment of render on a cornice coated with limestone wash (Phase 3).

that have been partly painted over with a thin white lime wash layer (Figure 7).

In cases where the renders were painted dry, there is another theory that could explain the presence of calcite in the coloured layer, namely the use of limestone as a binder. In this case, the terracotta sherds with white mortar deposits found in the Phase 1 trench in Room S12 could be limewash residues. Since murals painted on dry renders have a much shorter life than frescoes, the decorative motifs would have had to be repainted to remain visible and this is, in fact, the case for many of the samples. In Phase 3, after Phase 2 in which the temple was very badly damaged and therefore went through an intermediary period when it was abandoned, repainting consisted simply of applying a layer of whitewash, as can be seen from Figure 7.

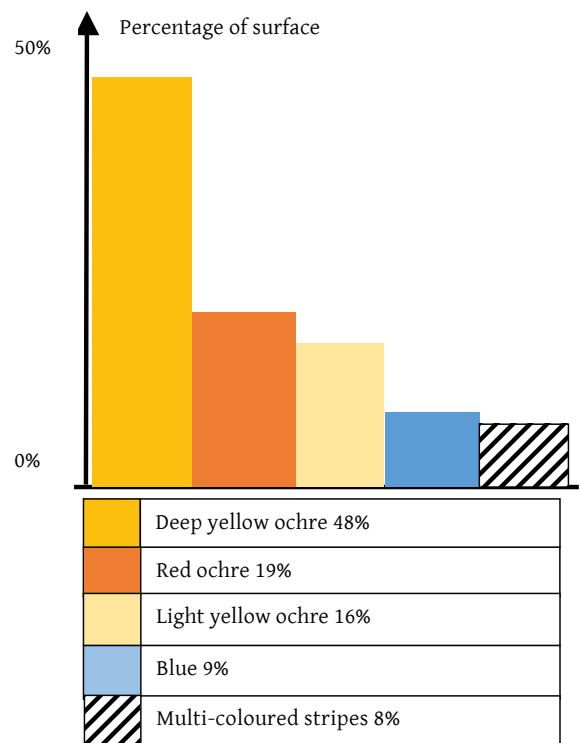
Figure 8. Statistical analysis of the size of the flat fragments, classified according to the colour of their outer surfaces.

It is worth noting that none of the flat fragments here have figurative motifs, in contrast with all the Meroitic sites decorated with painted renders<sup>6</sup> (see for example, Anderson and Salah Mohamed Ahmed 2011). Most of the coloured fragments are uniformly covered with a unique colour. A statistical analysis of the size of the flat fragments, classified according to the colour of their outer surfaces, was carried out to provide figures supplementing the qualitative data. The corresponding results are illustrated on Figure 8. Fragments bearing an even coat of yellow ochre may also be divided into two categories. The first of these are deep yellow in colour, at times with several quite thick layers of paint, which suggests that the paint was applied on dry renders (Figure 9a). The second is those in more or less pale shades of beige, from sand to eggshell, that show a slightly shiny finish when polished (Figure 9b).<sup>7</sup> The number of flat samples unearthed and their equivalent surface area differed greatly from one series of excavations to another. Despite this, their physical distribution was extremely regular. It would, therefore, appear that all the walls of the temple were covered in similar fashion with an approximately 10–20mm thick layer of plaster and that the fragments found all became separated from their base during or after the last phase of the temple's occupation.

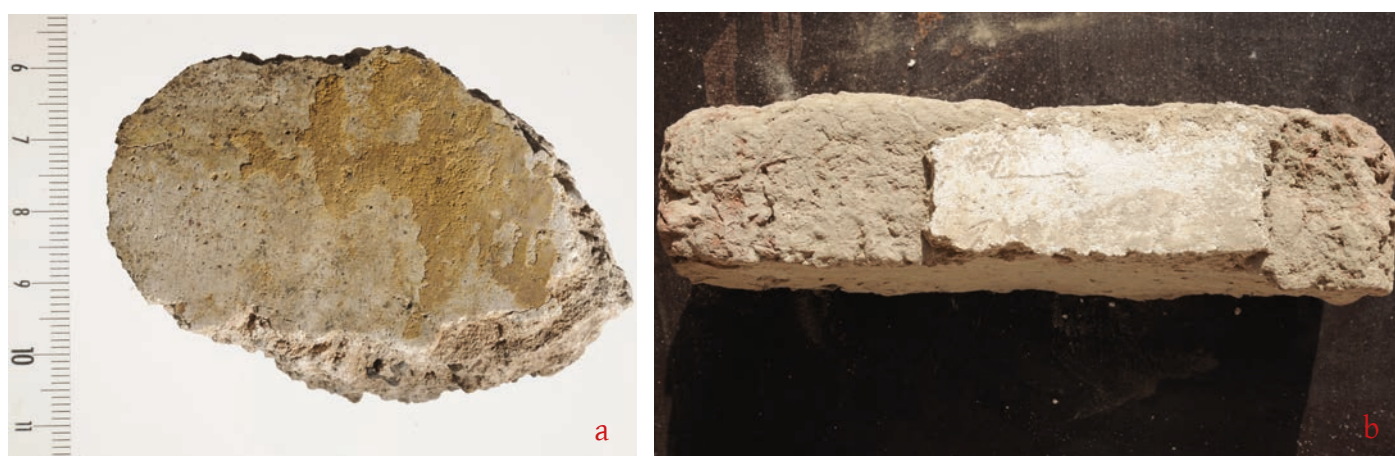
Figure 9. Illustration of the two painting techniques used. a. Paint applied on dry render. b. Polished paint on wet render.

For glossy renders, the structures are different in that the coloured layer comprises two sub-layers. The inner of these is thicker and consists solely of yellow ochre particles (goethite) mixed with calcite crystals. The outer sub-layer is about 10µm thick and also comprises ochre particles but no calcite. By contrast, it contains a large amount of magnesium, which could

be indicative of the presence of magnesium-rich clay, in other words palygorskite, commonly found on the banks of the Nile. Clays of this type form sheets when they crystallise, which gives them a highly silky appearance when polished. If allowance is also made for the fact that the ochre particles present in the innermost calcite layer, which are in direct contact with the mortar and therefore the result of the humidity that rises when pressure is exerted on a damp granular environment, could only have been deposited in liquid form, it is clear that the technique used by the builders of the temple was indeed *a fresco*. This means that the temple was built by people who had developed painting techniques and original pigments they could use to give a glossy finish to its most sacred parts.
