SUDAN & NUBIA

Building E at Damboya, the third and final season

Gabrielle Choimet

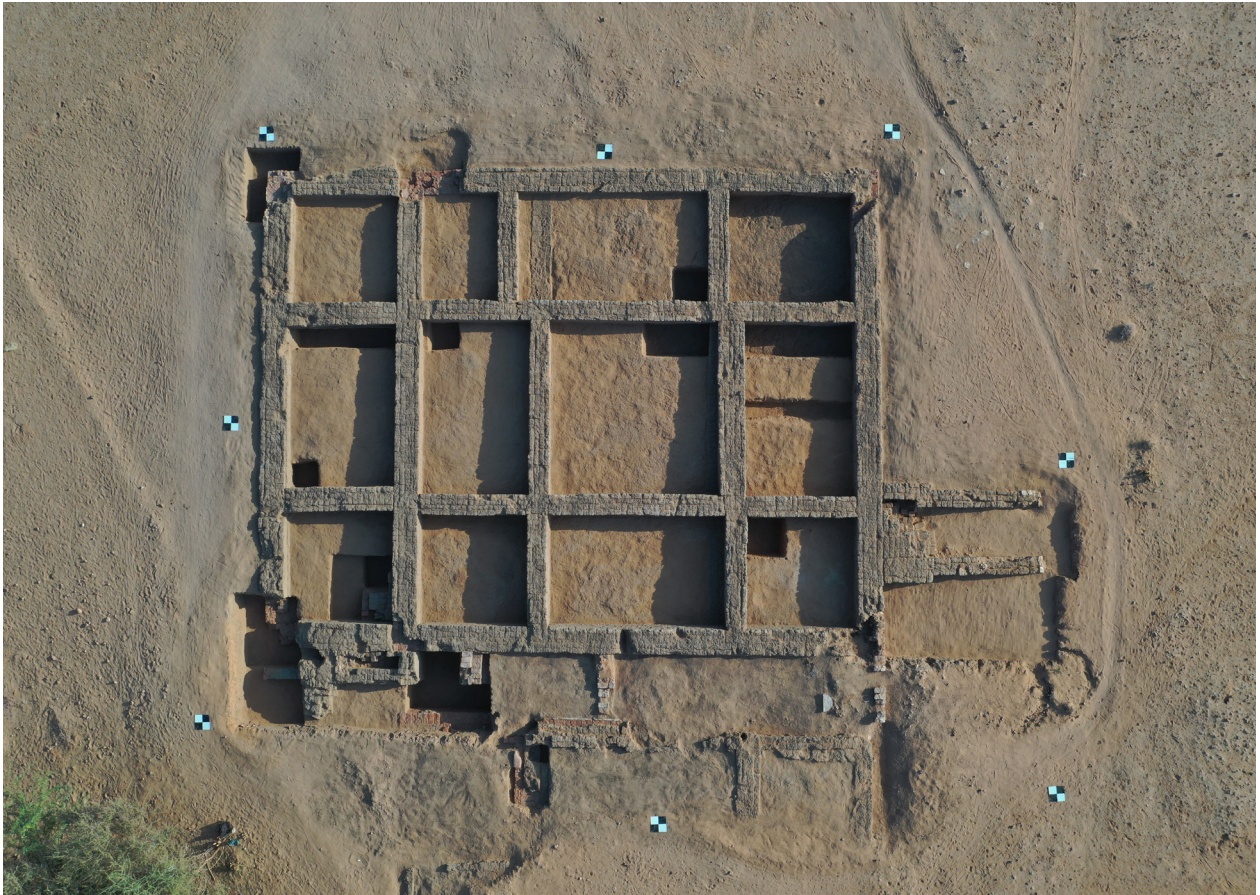
Figure 1. Aerial photo of Sector E after the 2022 excavations showing the neighbouring Building H at the bottom of the image (© SFDAS).

Surface clearing was previously undertaken in this sector in 2020; on this occasion, a number of additional features were uncovered, including a second building to the southwest now known as Building H (Figures 1 and 2). Study of the interior of Building E began in the 2021 campaign when six rooms in the eastern half of the building were excavated down to the foundation level. The remaining six rooms were excavated early this year (2022). Twelve sondages were dug inside and outside the structure below the foundation level to investigate the foundations of the walls, particularly at the corners.

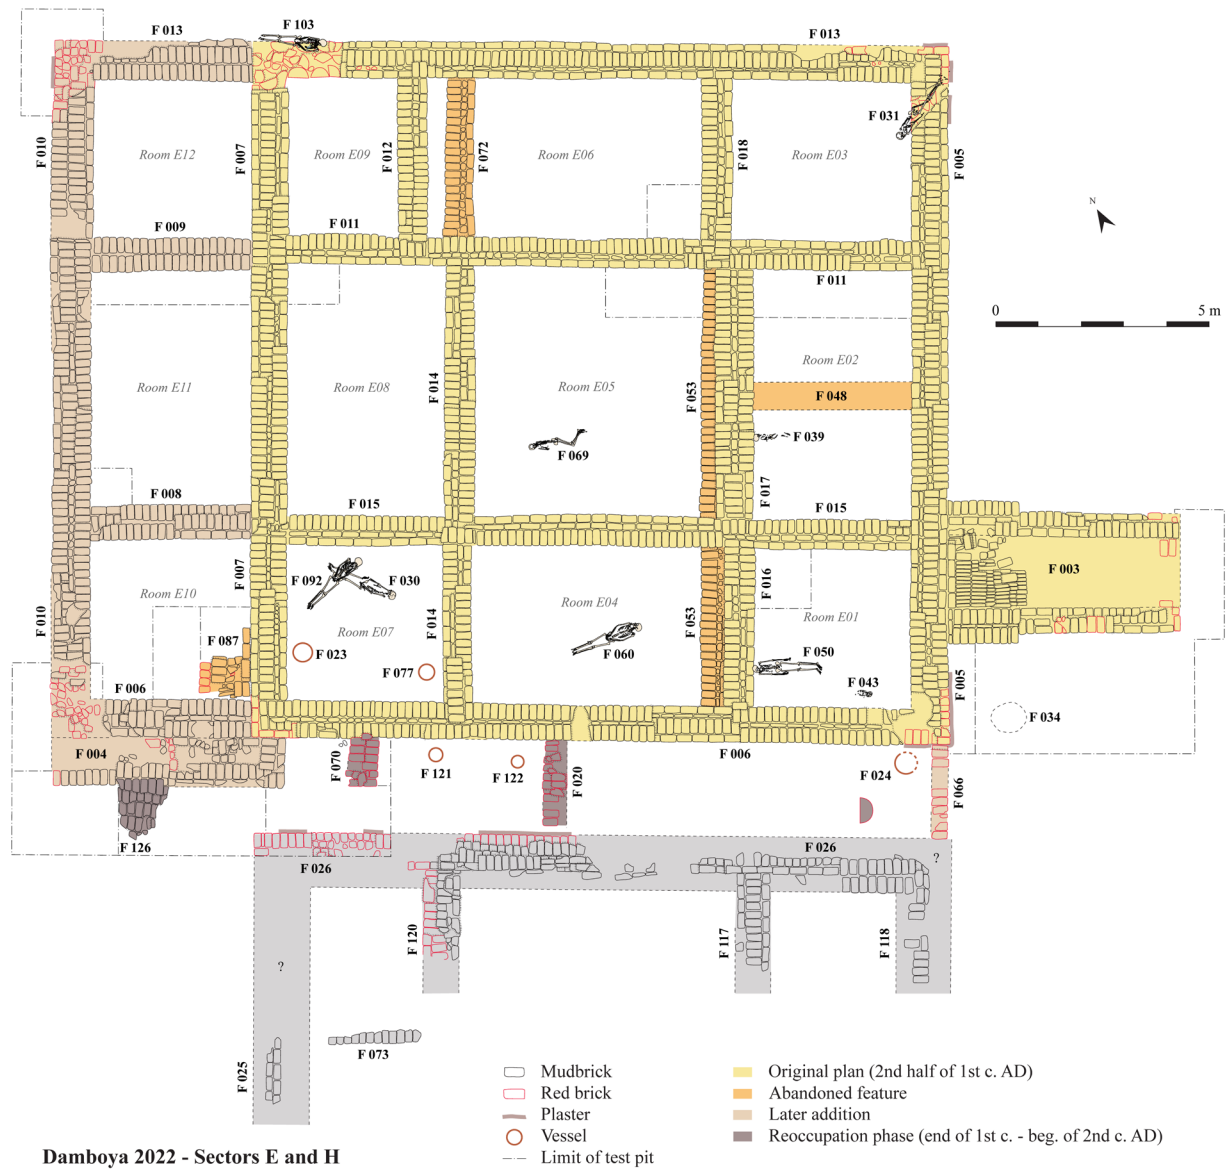
Figure 2. Plan of Building E and the northeast part of Building H (in grey) (© SFDAS).

This season enabled us to clarify certain points concerning the chronology of the construction of Building E. It quickly became apparent that the walls of the northwest bay (Rooms E10 to E12) were not perfectly aligned, nor even bonded with the rest of the structure, raising the question of whether or not they belonged to the original plan. In addition, several features abandoned during the construction were uncovered (Figure 2).

Another significant feature discovered during the 2022 campaign is Building H, a large building situated immediately to the southwest of Building E, the presence of which was suspected in 2020 after the discovery of two mudbrick walls perpendicular to each other – F 025 and F 026 – and because of the presence of a large number of red bricks and plaster fragments on the surface. Four more walls probably belonging to this second structure were uncovered during the 2022 campaign, of which at least the exterior walls seem to have been built of red bricks (Figures 2 and 10).

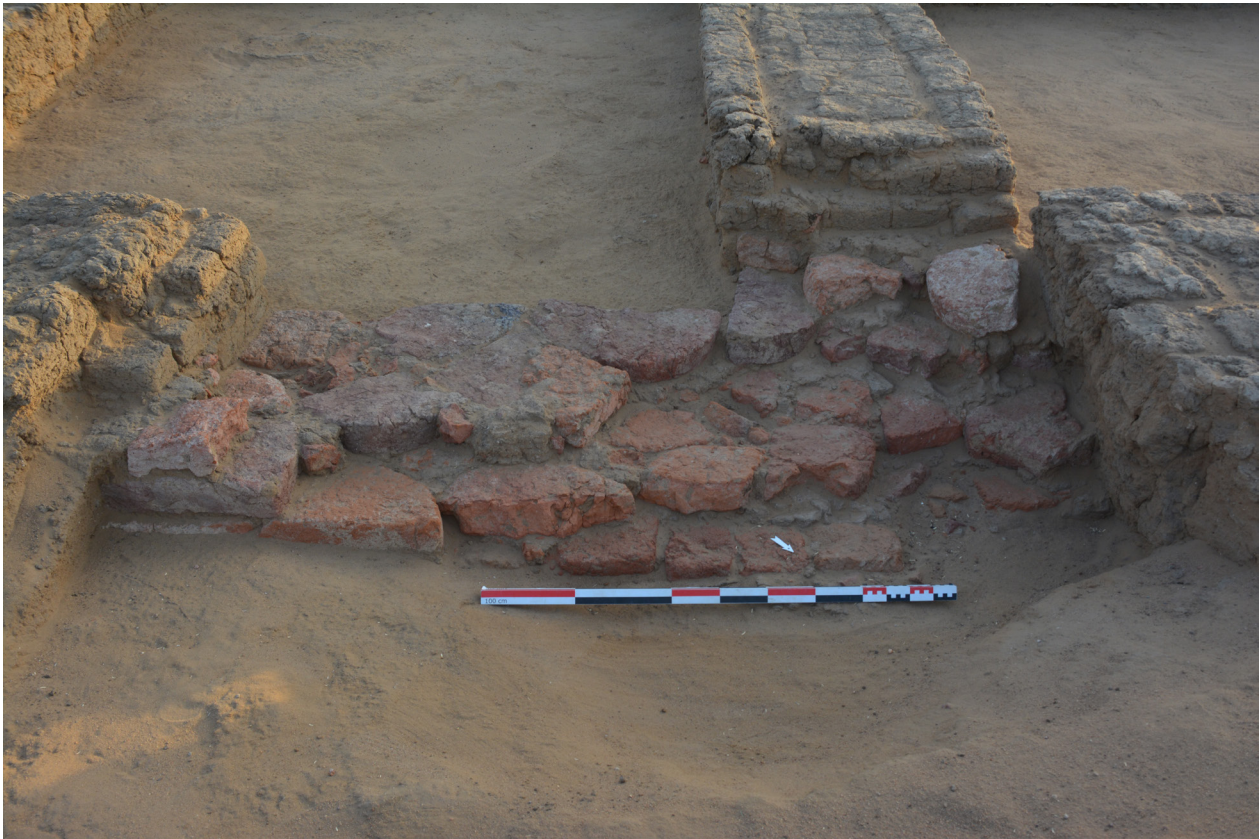
Figure 3. Corner F 007-F 013 showing the reuse of red brick column drums in the foundations of the original building (© SFDAS).

The disturbance of the north and west corners of the structure, as well as of Corners F 007-F 013 and F 006-F 007 by looters looking for red bricks, enabled us to observe that the foundations of the corners of the original building (Rooms E 01 to E 09) differed significantly from those of the later bay (Rooms E 10 to E 12). The foundation level of Corner F 007-F 013 shows an almost exclusive use of column drums (Figure 3), whole or fragmentary, and is reminiscent of that observed in 2021 in room E03, as well as in the external sondage at the foot of the corner formed by Walls F 005 and F 006 (Choimet 2021, 171, fig. 4). Similar column drums are visible in the foundations of Wall F 006, next to the corner with Wall F 007. In contrast, the north and west corners of the building (which correspond to the external corners of the

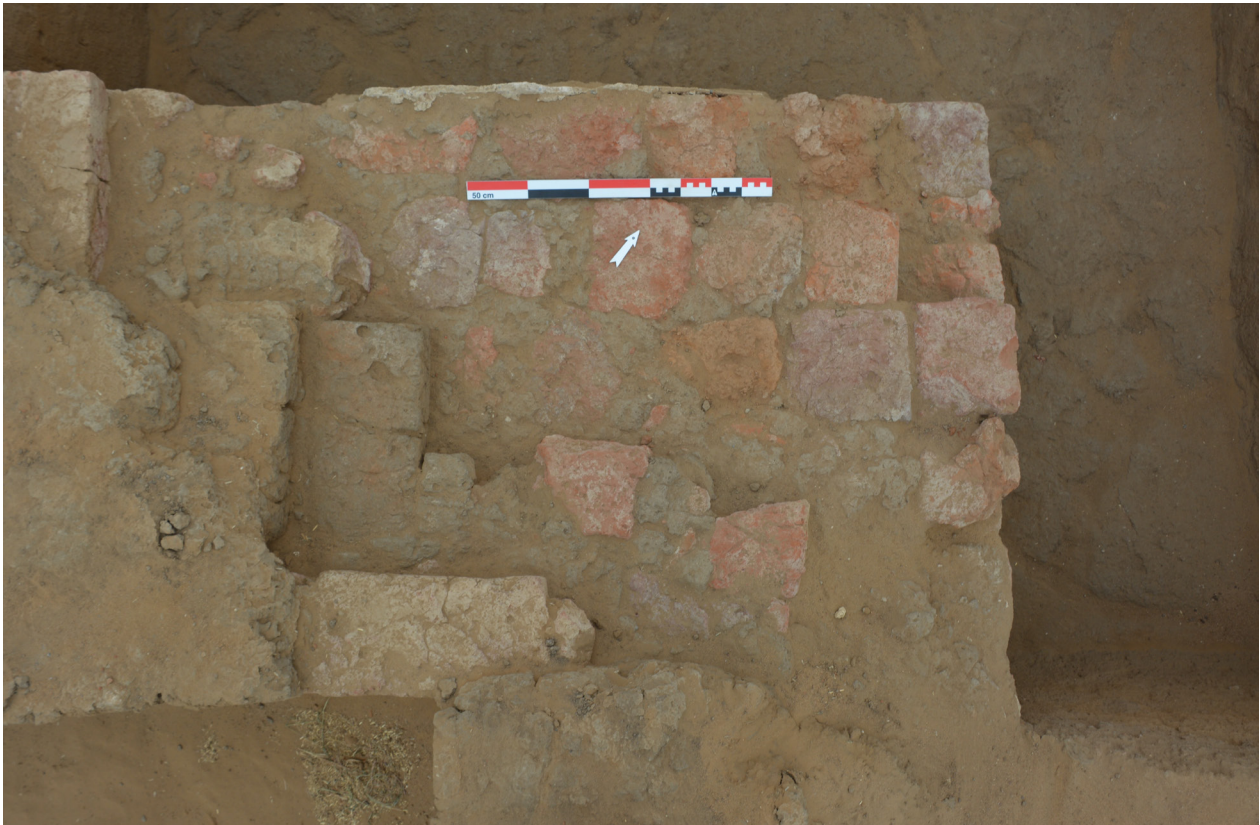
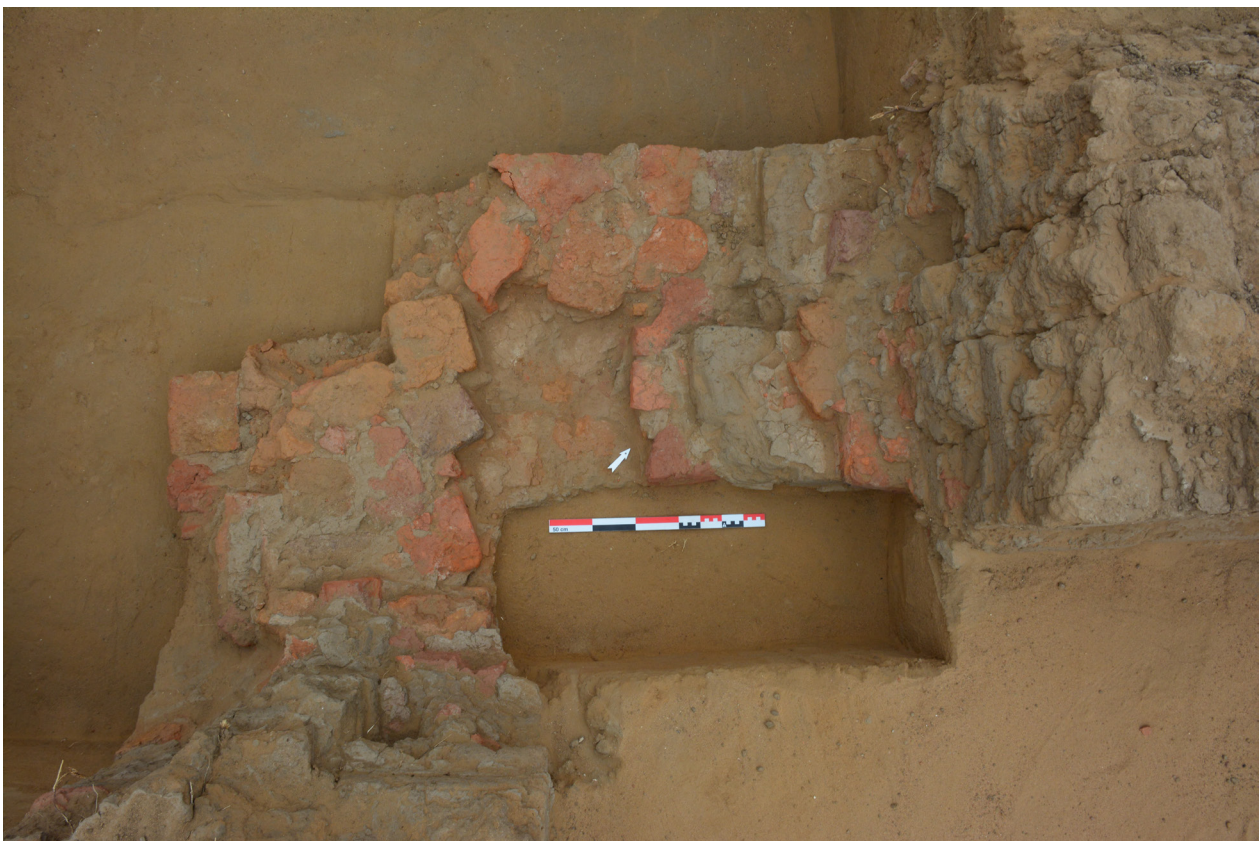
Figure 4. Corners F 006-F 010 (above) and F 010-F 013 (below) showing broken red bricks in the foundations of the new aisle (© SFDAS).

later bay (Corners F 010-F 013 and F 006-F 010), show completely different foundations of fragmentary red bricks embedded in thick grey mortar. Moreover, these foundations are shallower and comprise only four courses of bricks instead of six (Figure 4). The presence of architectural pieces inside the masonry indicates that building materials from a large edifice located nearby were reused for the construction of Building E. The outer façades were then coated with thick whitish plaster. The distribution and features of the fragments suggest that these façades were partly covered with yellow paint.

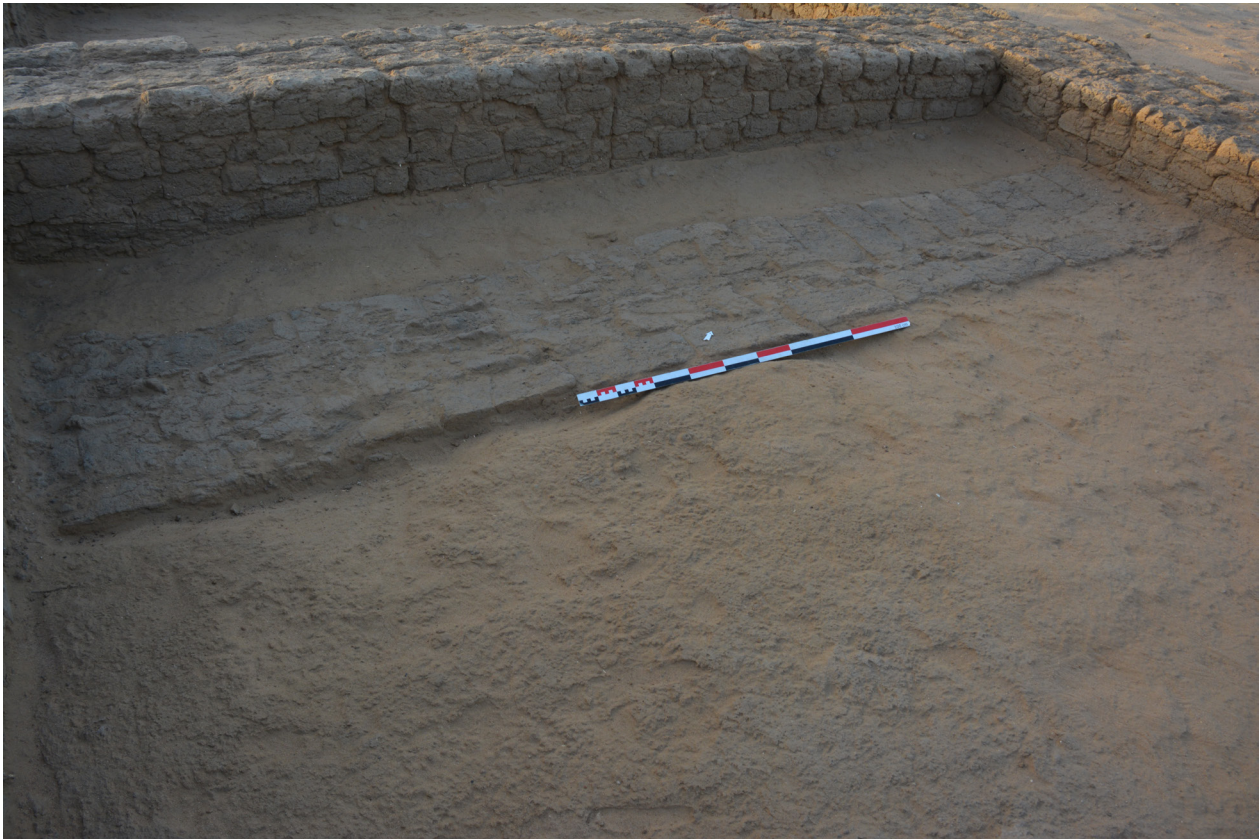
Figure 5. Wall F 072 with Wall F 012 in the background, view from the south (© SFDAS).

In Room E02, a trench c. 0.70m wide (F 048) was uncovered between its two long walls (Choimet 2021, 175, fig. 11). Intended for the foundations of a wall, it was never used and later filled with the same compact filling as the rest of the room. In Room 6, the foundations of a wall (F 072), situated in line with Wall F 014, also indicate a change, the wall being shifted by 0.45m towards the northwest, Room E09 the smallest in the building at only 9.5m² (Figure 5).

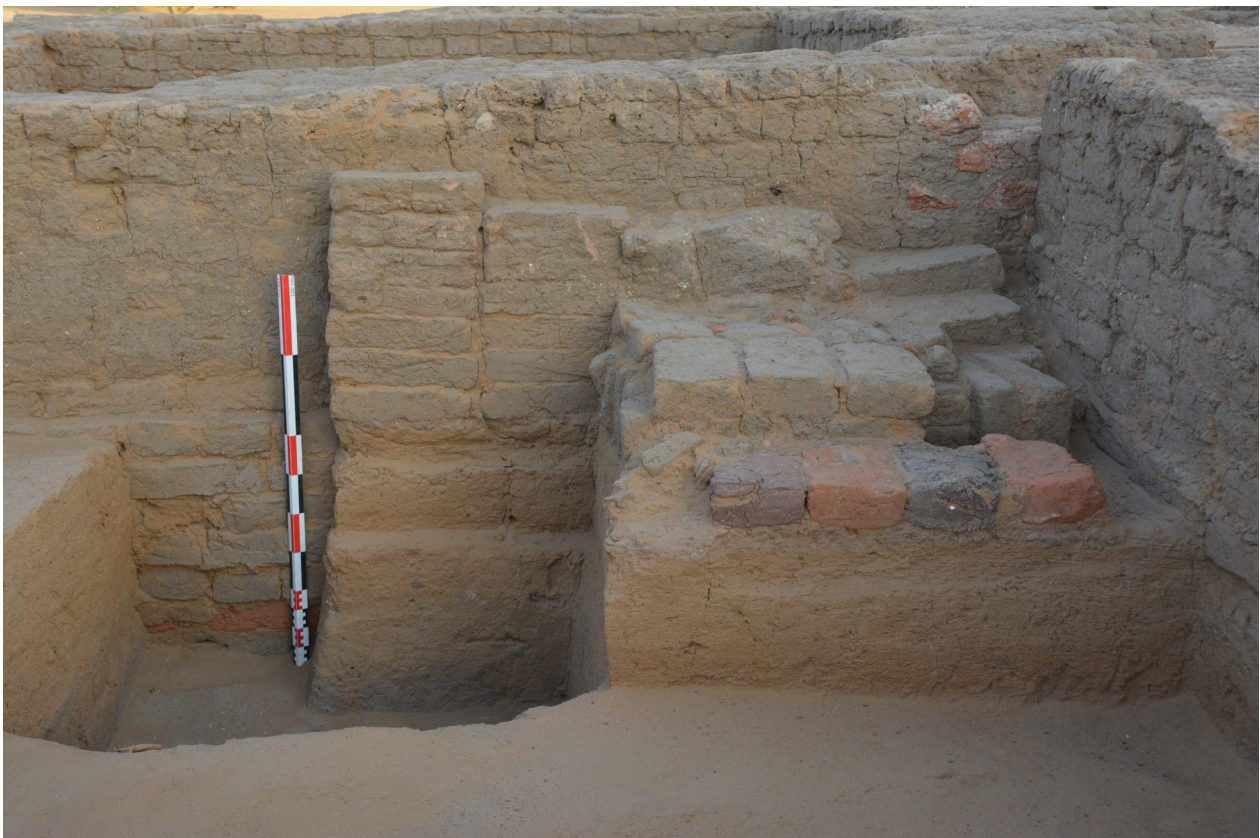
Figure 6. Staircase F 087, view from the northwest (© SFDAS).

The remains of a probable staircase (F 087) were found in the south corner of Room E10 (Figures 6 and 7). Built directly on the construction level without any foundations, it consisted of a row of four stretchers along F 007, preceded by a c. 0.70m wide filling of headers and broken bricks resting on a bed of bricks on edge; the whole carefully faced with a row of red brick headers. When excavated, F 087 had seven courses along Wall F 007 and a single course of red bricks at the other end. As the staircase had not been cut by adjoining wall F 006, this probably means that this feature was never completed, but was abandoned during construction. It is difficult to determine whether the original plan was a lateral entrance - like F 004 on the southwest side of the building - or if it was perpendicular to the ephemeral façade represented by Wall F 007. However, the comparison with F 004 - especially in terms of layout and width - makes a side entrance more likely.

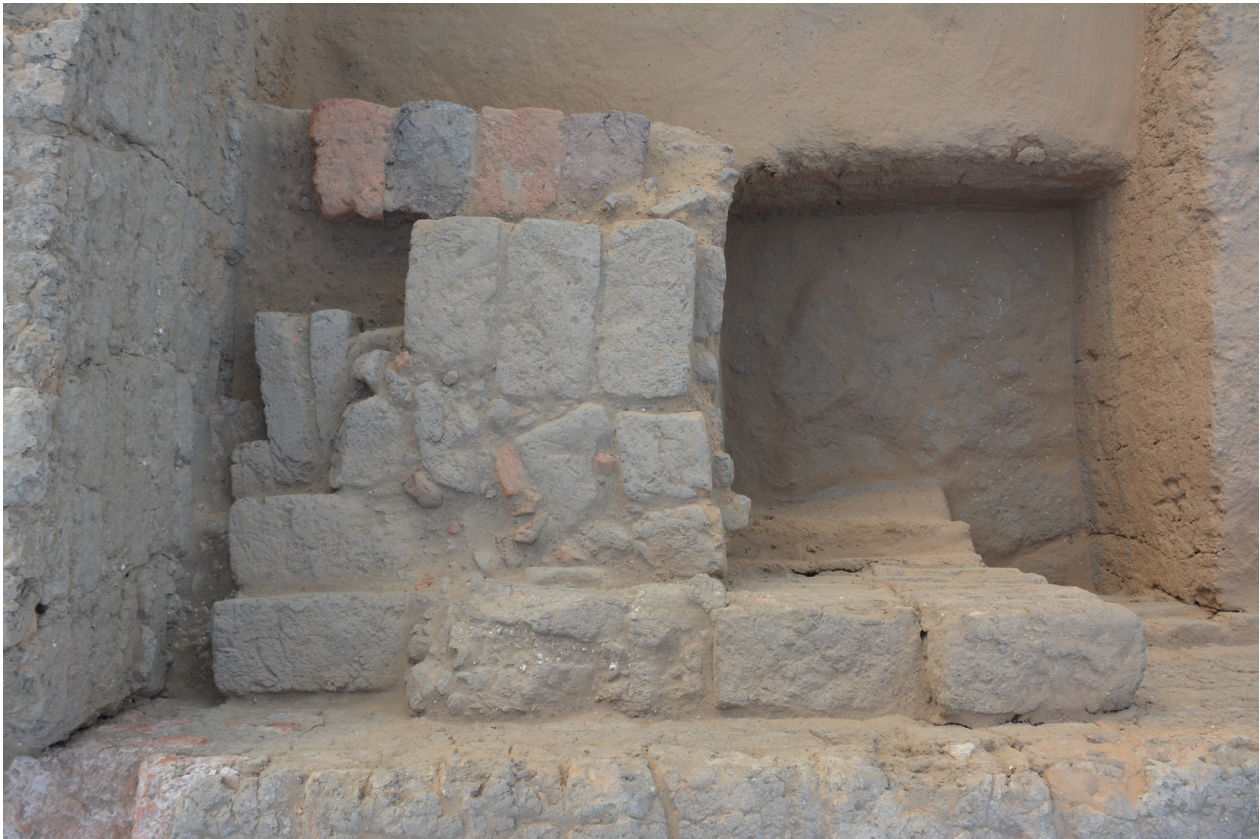
Figure 7. Staircase F 087, view from above (© SFDAS).

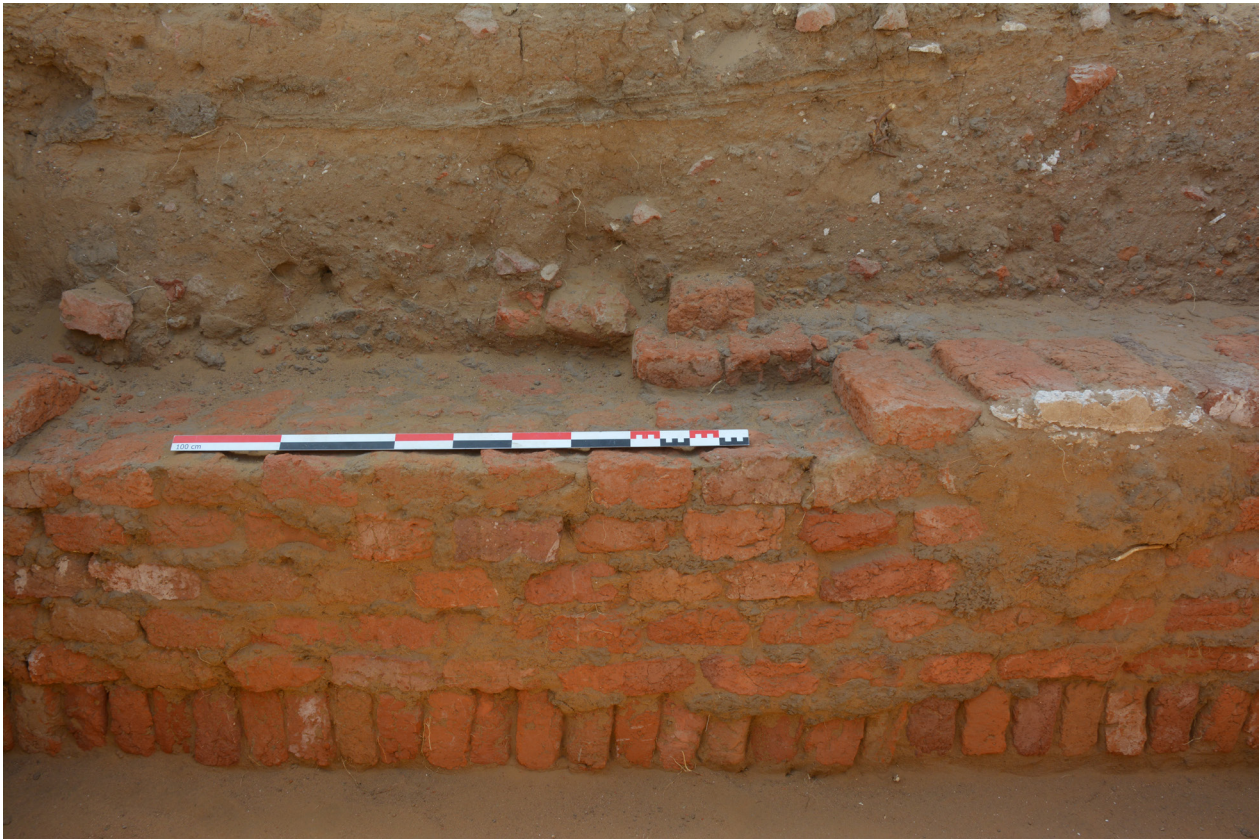
Figure 10. Red brick foundations of Wall F 026 of Building H, view from the northeast (© SFDAS).

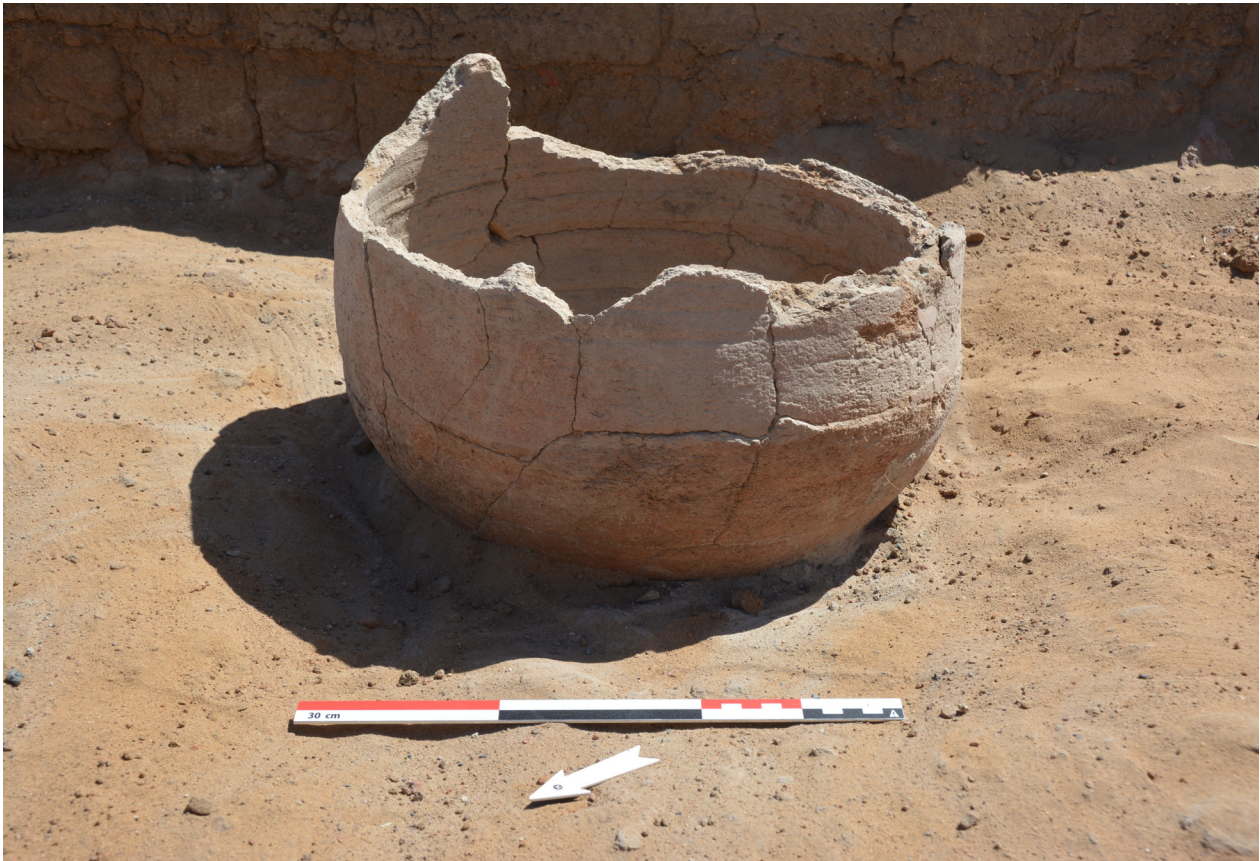
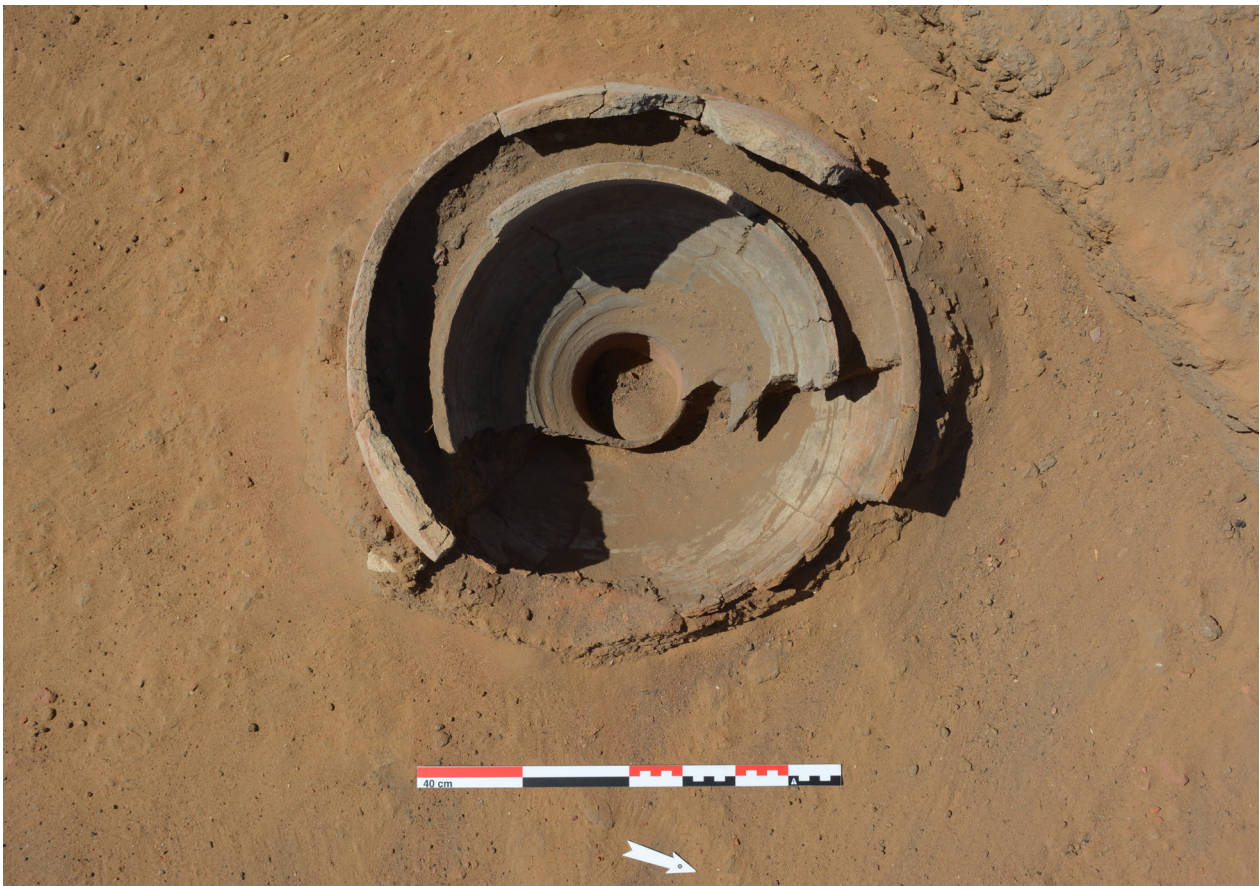
Figure 11. Ceramic vessels F 077 (above), and F 023 (1) and (2) (below) set into Casemate E07 (© SFDAS).

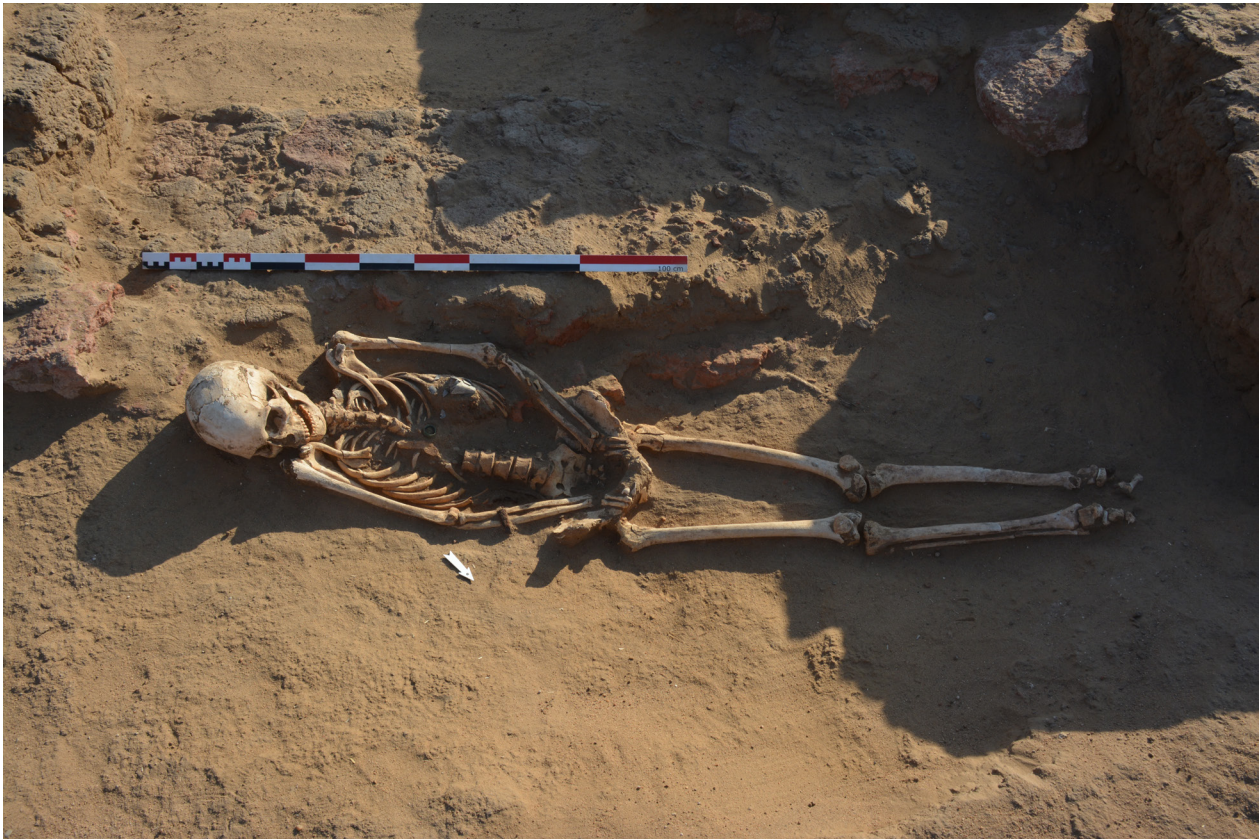
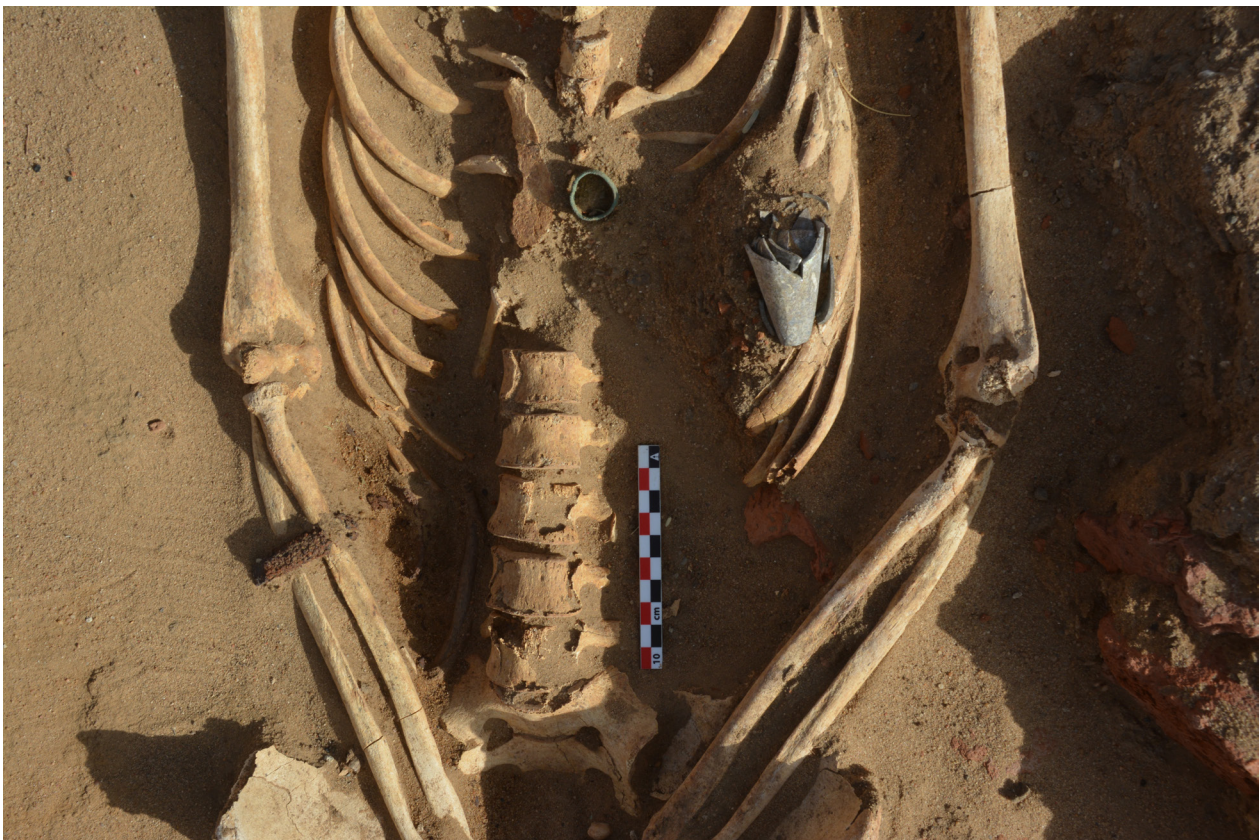
Figure 12. Grave F 103 (above) with detail of the funerary material accompanying the deceased (bottom) (© SFDAS).

Except for a secondary deposit containing the skeletal remains of two adults, all graves in Sector E are primary deposits and individual burials - among which two immature individuals were found - like those found in Sectors A and G.⁴ All but one were placed in a supine position, sometimes slightly inclined to the right or the left. No funerary material was found apart from a few glass beads. Grave F 103 therefore stands out, as the deceased had been buried with an iron bracelet on the right forearm, a glass flask on the left side and a bronze ring on the chest, possibly worn on a string (Figure 12).
