# SUDAN & NUBIA

Bulletin No. 10 2006

# Preliminary report on the excavations conducted on Mis Island (AKSC), 2005-2006

Andrew Ginns

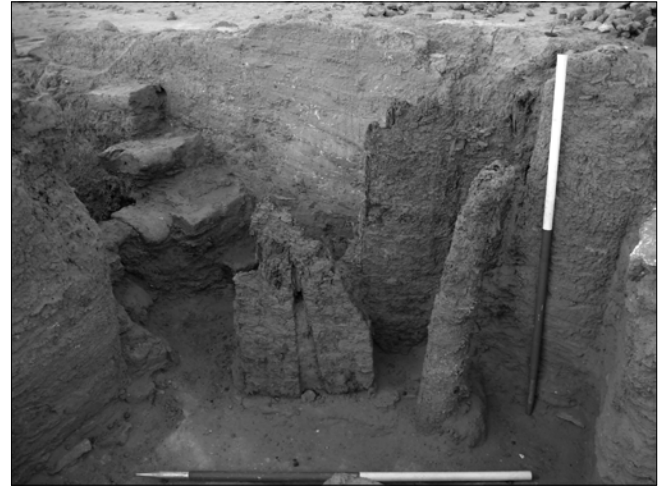
Plate 2. Internal stairs and remains of stairwell doors.

these arches perhaps supporting a cupola above. There is some evidence for arches running from the northern pillars to the northern exterior wall; fired bricks within the northern wall, in line with the pillars, hint at this. Each of the pillars is built abutting a wall, they are not isolated components. Three of these walls run in line with the nave of the church (east-west) demarcating the nave from the aisles. The wall abutting the south-western pillar ran north-south from this pillar to the southern exterior wall. This wall enclosed the staircase in the south-west corner of the church. The staircase (Plate 2) was constructed of fired bricks set on a foundation of compacted silt and sand, between the large mud-brick newel and western external wall. The stairs survived to a height of four flights; they would have encircled the newel, climbing upwards in an anti-clockwise direction. The absence of any silt/sand fill on the east side of the newel which would have supported the upper steps indi-

cates that these would have been of wood. The upper steps may have been constructed of beams running from the newel to the wall to its east, probably set into those structural components.

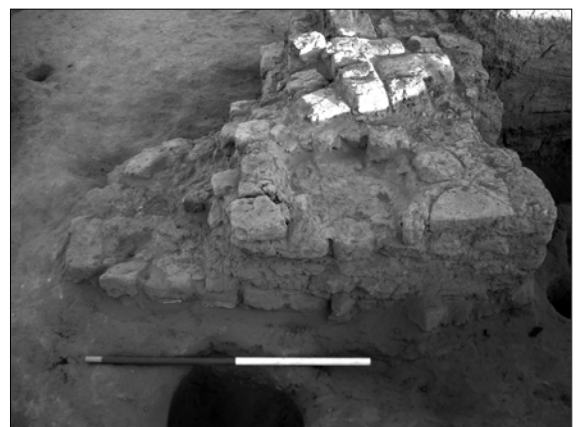
Plate 3. The pulpit looking north.

The second phase of construction within the church (Figure 3) saw the addition of a pulpit and the strengthening of the northern pillars. The pulpit was built of fired bricks laid in a rather haphazard fashion and not to the same quality as the original fired-brick structural components (Plate 3). The west end of the pulpit is a single course of bricks set in a semi-circular shape; this represents the first step with the structure rising to six courses high at its east end. The shape of the pulpit with the steps leading from the nave is indicative of its purpose being for sitting on rather than for standing. This addition lies stratigraphically 10cm above the north-east pillar against which it is built. It probably replaced an earlier pulpit, perhaps built of a less durable material. However, no signs of an earlier pulpit were evident.

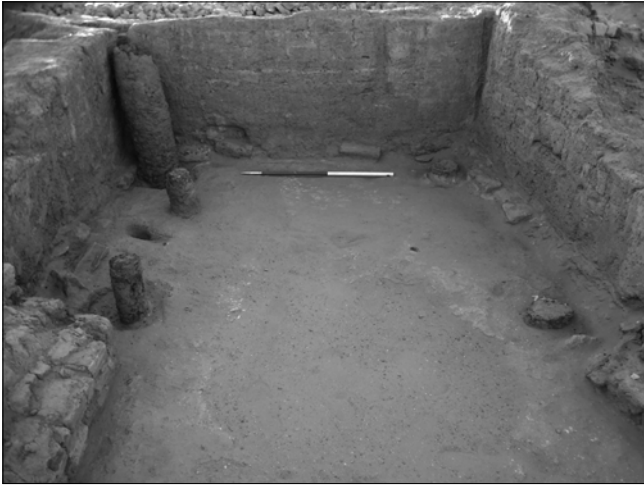
Plate 5. The north-western corner of the church/west of northern aisle.

At the western end of the northern aisle were five wooden pillars (Plate 5). These were set into holes cut into the original floor level and respected the shape of the end of the aisle. As with the internal steps, galleries utilising wood would have had a limited lifespan. These wooden posts may, therefore, be supports for a replacement gallery entered from the external staircase.

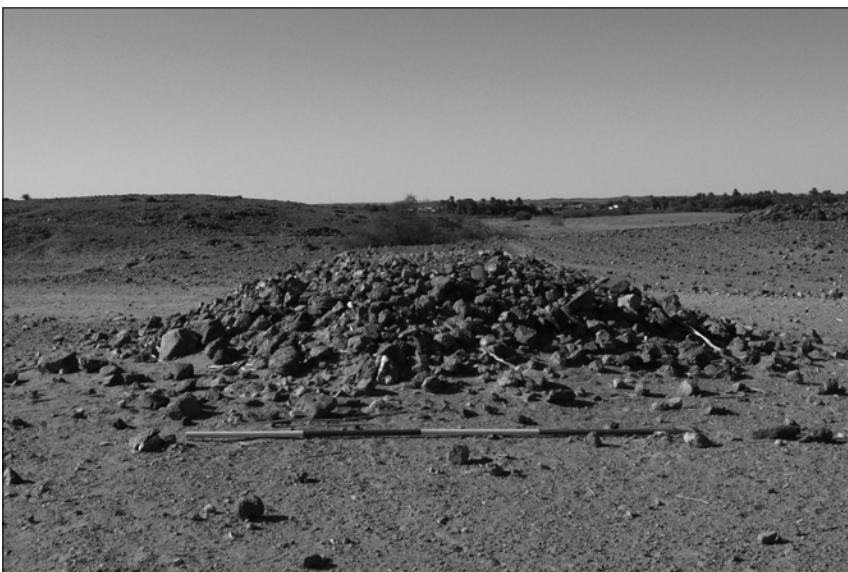
*Plate 9. Tumulus 3-J-12.*

Roughly 300m south of site 3-J-11 and 300m west of site 3-J-18 was an isolated mound (Plate 9). This was set on a gently undulating area of ground near the centre of the island. The mound was constructed of a sand/silt matrix with gravel and angular stones. It was constructed in one event and contained potsherds of medieval date. It was

roughly circular with a diameter of 5m and a height of 0.65m. Its purpose is unclear; full excavation revealed that it did not mark a burial or any other deposit. It could theoretically have been a marker within the landscape, but this is unlikely considering its island location.

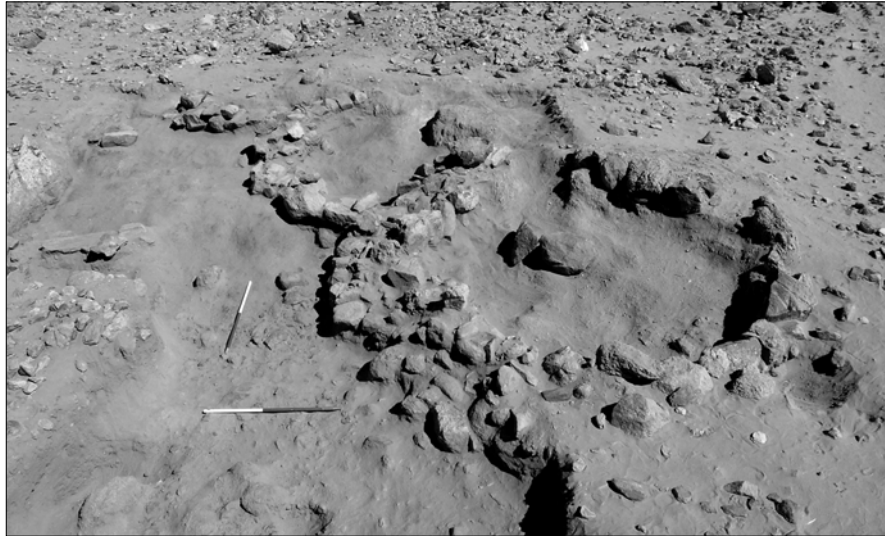
*Plate 10. Circular structures: round houses/ animal pens.*

A test pit dug near the centre of the site revealed two circular rings of unworked rocks with further rocks forming walls leading off from these (Plate 10). The absence of a clear archaeological horizon within the dirt layers in and around these structures meant that a precise function could not be attached to them. The circular shape would suggest that the rocks are not foundations of mud-brick structures but are the lower courses to dry-stone walls. The small size of these structures is suggestive of their being animal pens.
